**DEPTH OF BORINGS,  
LENGTH OF PILES,  
LANDSLIDES, EROSION,  
AND  
A MOOSE HUNT**

**A CASE HISTORY OF A COMEDY OF MISTAKES**

**Bengt H. Fellenius**

**Geotechnical News Magazine  
1989, Vol. 7, No. 2, pp. 54-55**

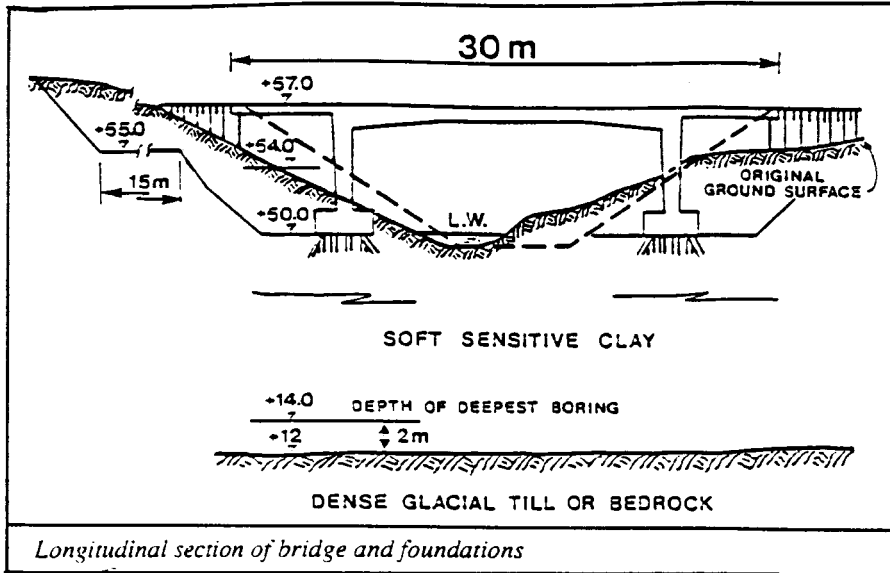
An upgrading and straightening of a highway included building a bridge across a small river. A routine site investigation was initiated to determine the conditions for designing the foundation of the bridge. The proposed bridge was a two-lane highway bridge in one span with a total length of 30 m (100 ft), as indicated in Fig. 1. It was to be placed about 20 m (66 ft) upstream of a bridge for the existing highway.

As shown in Fig. 1, the foundation elevation of the abutments was about 4 m (13 ft) below the ground elevation at the boring locations necessitating excavation prior to the piling work. There

was some concern as the stability of the excavations and the slopes. To address this problem, it was specified that the excavation should be made about twice the width necessary for access and that all soil above an elevation 5 m (16 ft) higher than the excavation bottom be removed within a distance of 15 m (50 ft).
