Fellenius, B.H., O’Brien A.J., and Pita, F.W., 1982. Construction control by monitored geotechnical instrumentation for Port of Seattle New Terminal 46. Transportation Research Board, Symposium on the use of Field Measurements and Observations to Design and Construct Pile Foundations, January 1982, Washington D.C., Transportation Record No. 884, pp. 14 – 22.

Construction Control by Monitored Geotechnical Instrumentation for New Terminal 46, Port of Seattle

BENGT H. FELLENIUS, ARTHUR J. O'BRIEN, AND FRANK W. PITA

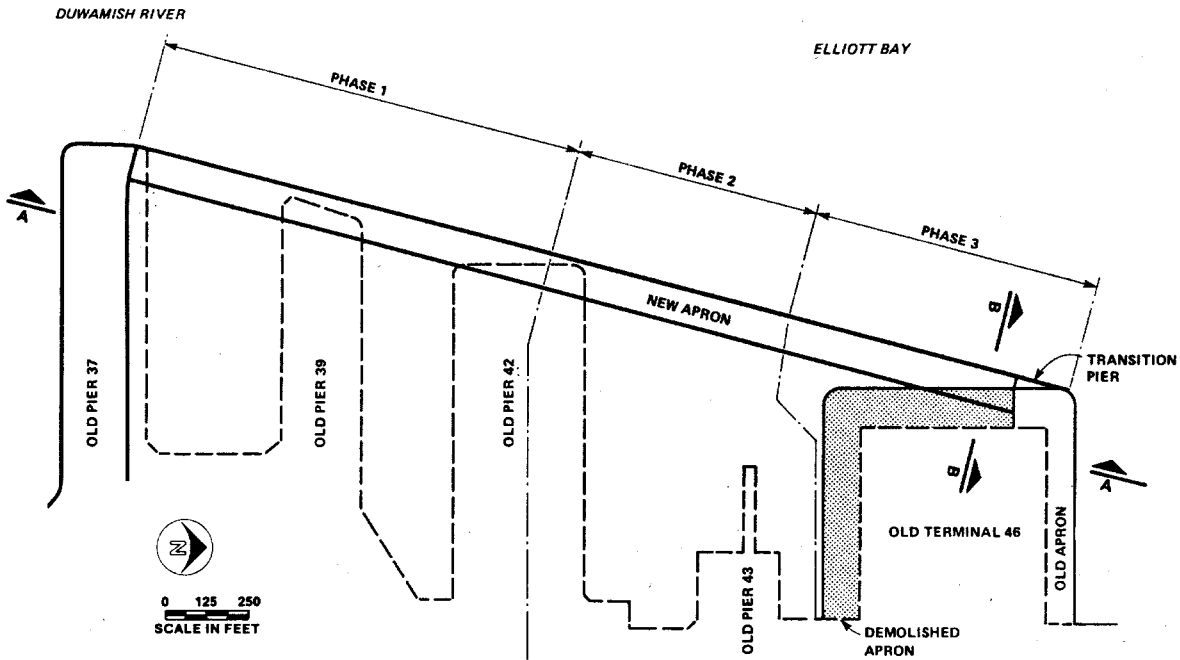
Figure 1. Site plan, Southeast Harbor Development Project.

The Port of Seattle implemented the Southeast Harbor Development Project to improve existing waterfront facilities and to provide new facilities for handling the growing volume of containerized cargo. Phases 1 and 2 of this project, which occurred between old pier 37 and old terminal 46, were completed in 1979. Phase 3, which consisted of a modification and lateral extension of old terminal 46, was completed in 1980. The completed facilities include 86 acres of a container storage and handling area; five container cranes will operate on 2740 ft of the pile-supported apron structure (Figure 1).

During the construction of phases 1, 2, and 3, pier 39 and portions of piers 37, 42, and 43 and old terminal 46 were removed (Figures 1 and 2). An earth-fill embankment was built at the outer edge of the old piers. A container storage area was then constructed by filling between the old piers and the new embankment. A pile-supported apron deck was constructed on the outer slope of the new embankment.

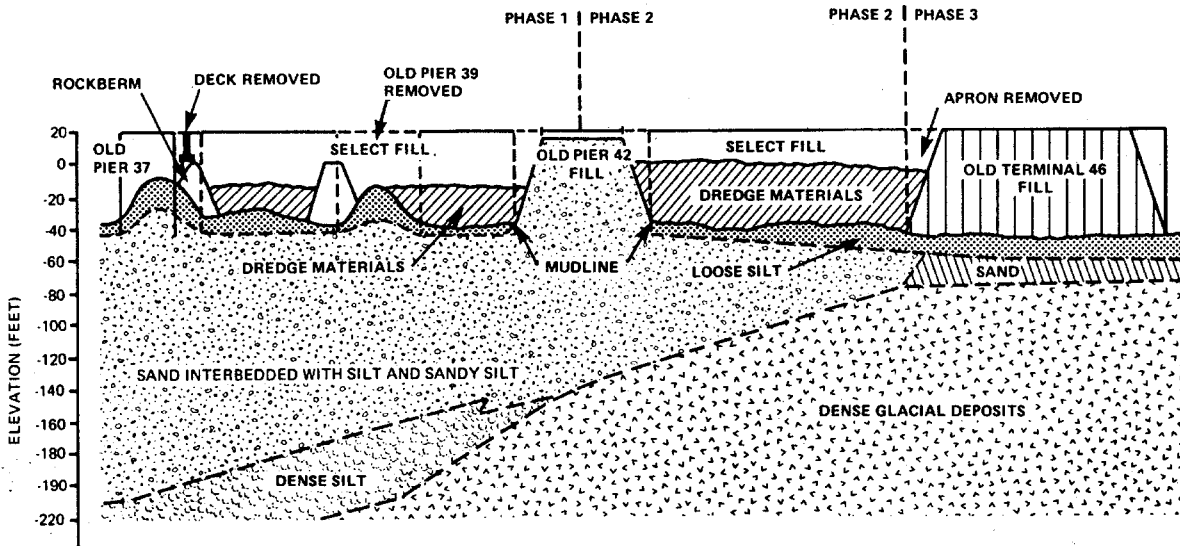
Figure 2. Section A-A of Figure 1.

consisted of modifications to old terminal 46 (Figures 1 and 2). The major modifications included demolition of the south apron and approximately 630 ft of the west apron, placement of more fill to extend the embankment to the west, and construction of a new concrete apron that would connect to the previously constructed (phase 2) apron at the south. A transition section was constructed to connect the new and old terminal 46 aprons at the north. The design criteria for the apron structure and embankment of new terminal 46 were provided by the Port of Seattle. They are summarized below:

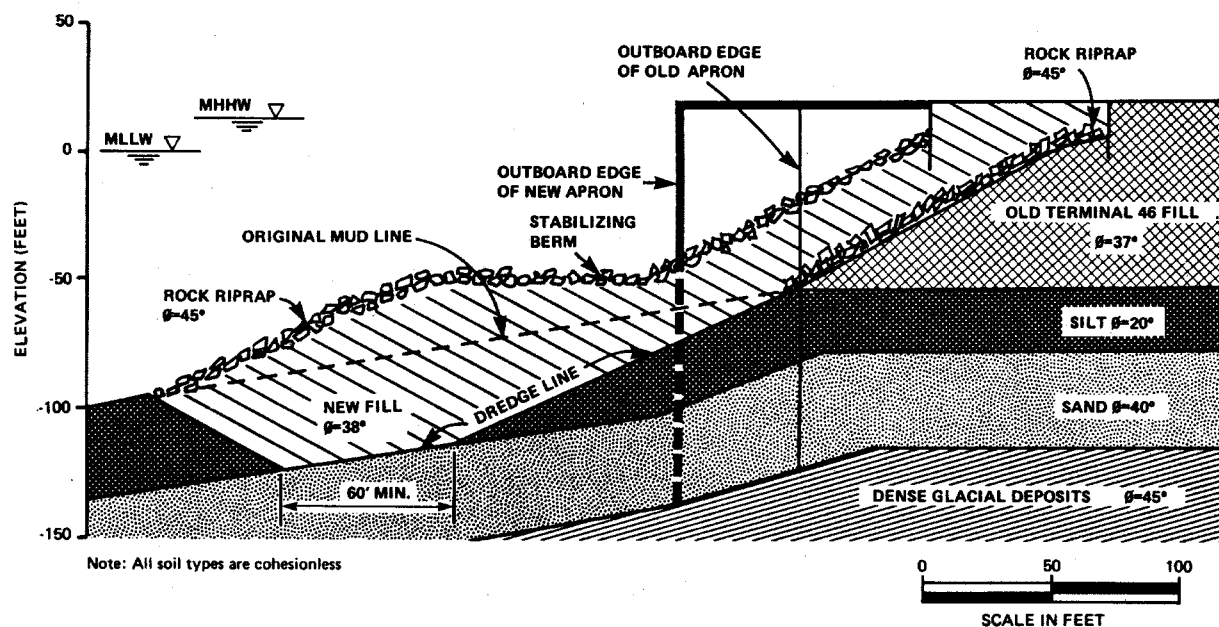
Figure 3. Section B-B of Figure 1, old and new construction.

Figure 3 (section B-B of Figure 1) presents a simplified vertical section across the site. Very dense glacial deposits underlie dense sand, which is covered by a layer of loose silt sloping toward the bay. The silt varies in depth and forms the base on which fill for old terminal 46 was placed. Ensuring the stability of the new fill with the presence of the loose sloping silt layer became the major concern in the geotechnical design.

The subsurface profile shown in Figure 3 was used

to model the most critical section of the embankment. Because the new apron deck joins the existing apron at an angle, the relative locations of the new and old aprons change throughout the site. Figure 3 shows the profile at the intersection between the existing apron and embankment and the new apron and embankment. At the intersection, a limited amount of silt beneath the fill could be dredged without disturbing old terminal 46 fill, and a minimum thickness of new fill could be placed over the silt and still allow for the required draft clearance. Also shown in Figure 3 is a stabilizing berm out-board of the new embankment. The stability analysis indicated that this stabilizing berm must be included to attain acceptable stability for final conditions under earthquake loading.

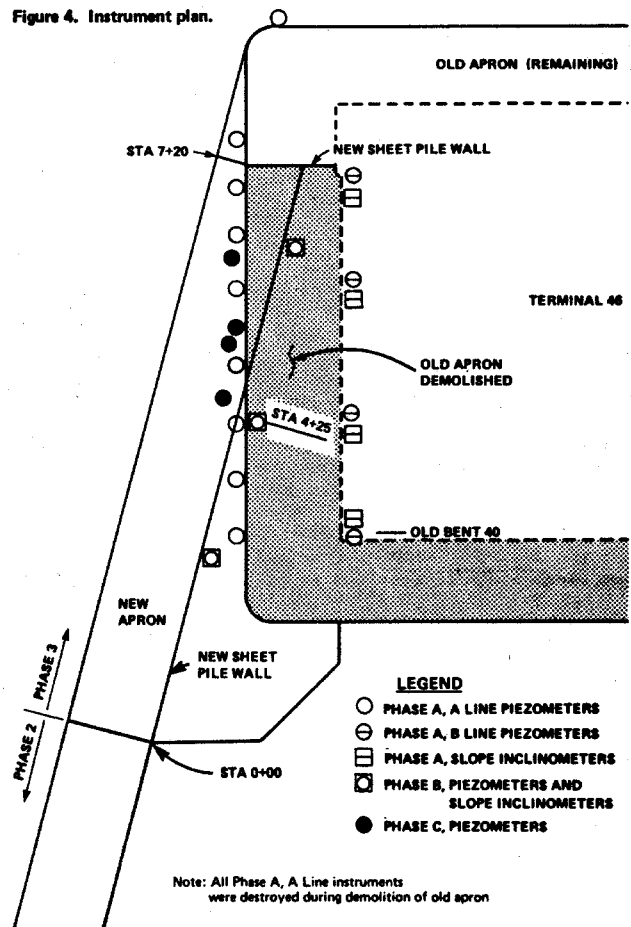
Figure 4. Instrument plan.

The piezometers used for the project were Petur Model P-102 Wellpoint. The inclinometers were Slope Indicator Company Model 50325 Digitilt. The instruments were installed in three phases during construction to accommodate the various conditions at the site. A total of 36 piezometers and 7 inclinometers was used. Figure 4 shows the location of the instruments. Figure 5 shows the approximate depths of the instruments in cross section.

Only minor increases in pore pressure were observed during the dredging operation (October and November 1979). These small increases did not approach the yellow level. Figure 7 shows the pore pressures observed at old bent 40 (Figure 4) during the filling operation. Filling began at the south end of the new embankment while dredging was being completed at the north.

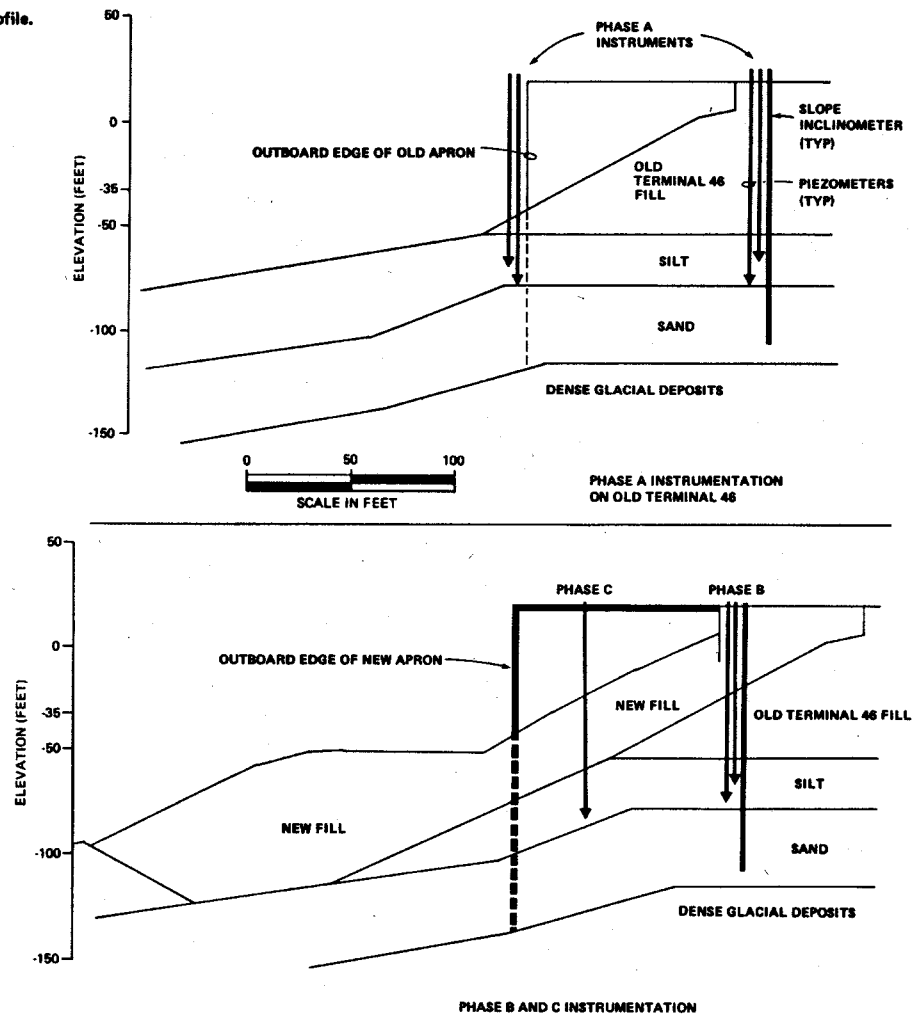
Figure 5. Instrumentation in profile.

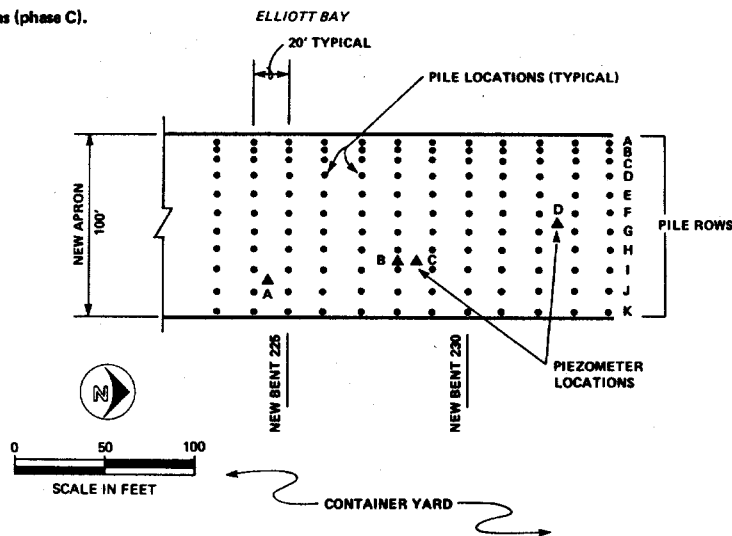
Figure 6. Piezometer locations (phase C).

Phase C instrumentation was installed in May 1980 and consisted of four piezometers. These instruments were installed adjacent to the pile-driving operation (each within 10 ft of a pile location) to monitor local pore-pressure increases during driving. Figure 6 shows the detailed location of phase C piezometers in relation to pile locations.

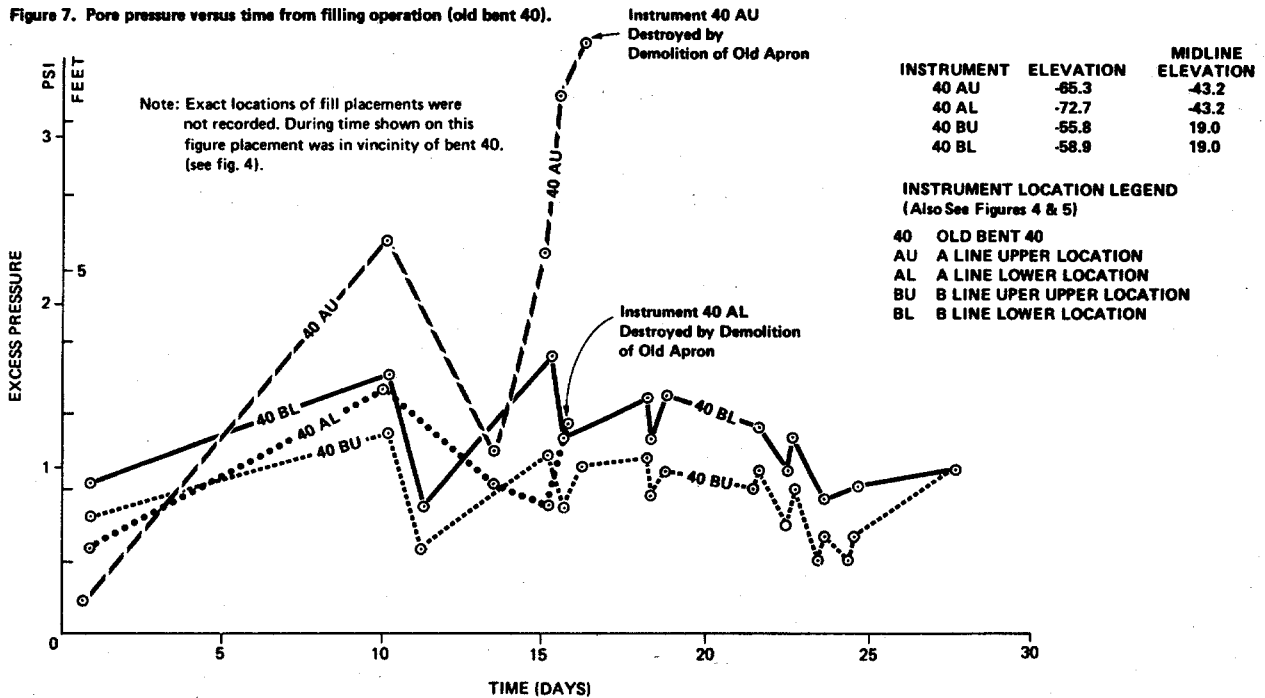
Figure 7. Pore pressure versus time from filling operation (old bent 40).

a piezometer, the pressures typically rose and then dissipated during the next 1-2 h if no additional dumps were made in the vicinity. Piezometer 40AU on day 14 (Figure 7) showed the accumulated effect of several successive dumps close to its location. Coincidentally, this piezometer was destroyed shortly after this reading.

During filling, the observations indicated no instability except when several dumps were concentrated in one area (Figure 7). As a consequence, the continued dumping of fill was distributed over a larger area to keep the pore-pressure increases low.

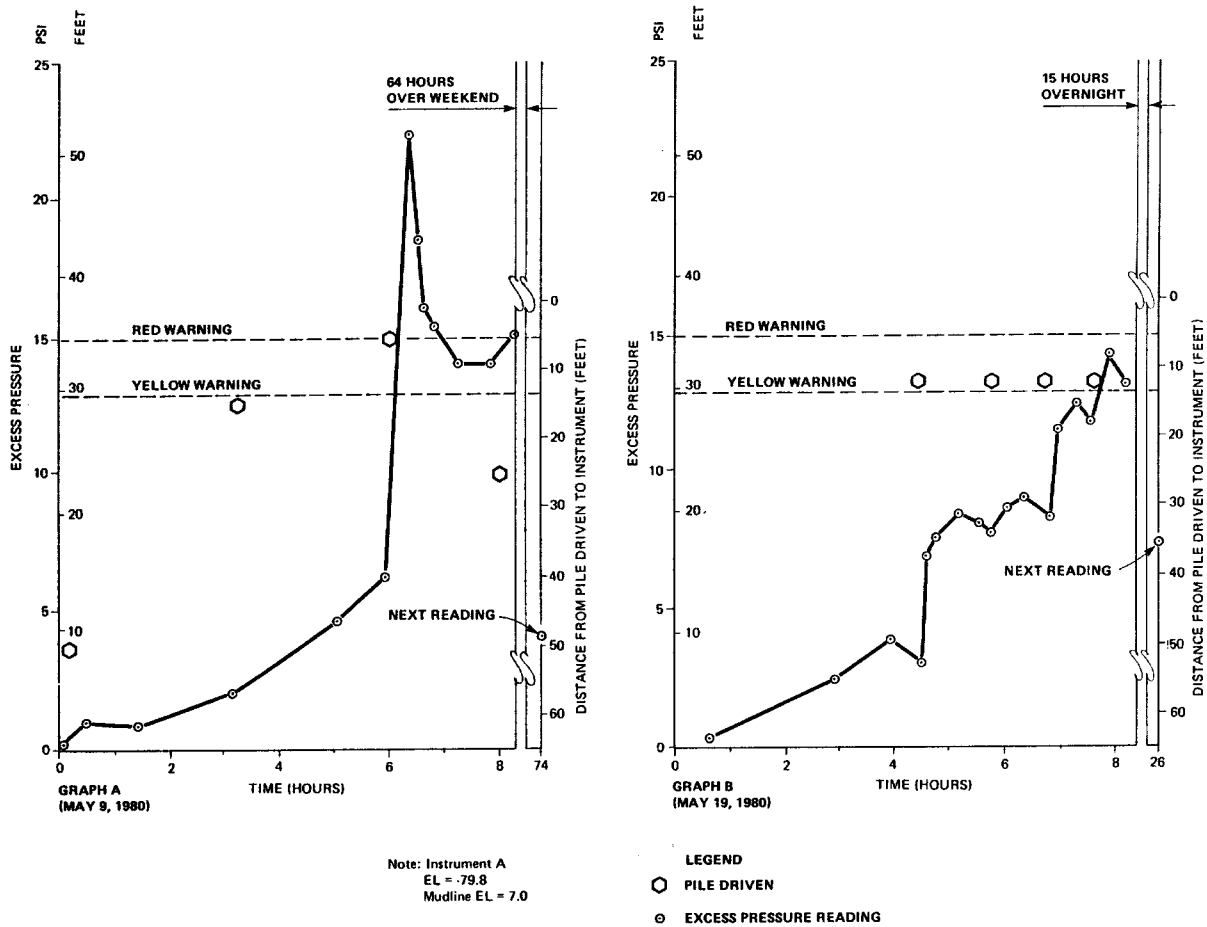
Figure 8. Instrument A pore-pressure increase during pile driving (phase C).

Figure 8 presents pore-pressure data taken from piezometer A of phase C during the pile-driving operations. Two separate sets of data are shown on each graph to give the relation among increase in excess pressure, distance from driven pile to piezometer location, and time. The first set of data (connected by the line) shows excess pore pressure

(left ordinate) as a function of time (abscissa). The second set of data (hexagons) shows the distance from the driven pile (right ordinate) as a function of time.

Graph A of Figure 8 shows the relation between pile-driving distance and pore pressure. Piles driven more than 50 ft away did not significantly affect the pressures. However, as pile driving moved to within 15 ft, pressure increases were noticeable, and a pile driven within 5 ft caused sharp increases. Pore pressures dissipated rapidly after the sharp increase and increased again as the final pile for the day was driven 25 ft away. Dissipation occurred when no piles were driven nearby.

Graph B of Figure 8 shows the results of driving four successive piles within 12 ft of piezometer A. Results were cumulative, in that each pile caused an increase in pressure followed by a slight dissipation before the driving of the next pile. Each additional pile caused the same effect, which resulted in pressures above the yellow level; however, dissipation occurred overnight.

The pressure decreased more slowly than during the initial pile-driving observations (Figure 8).

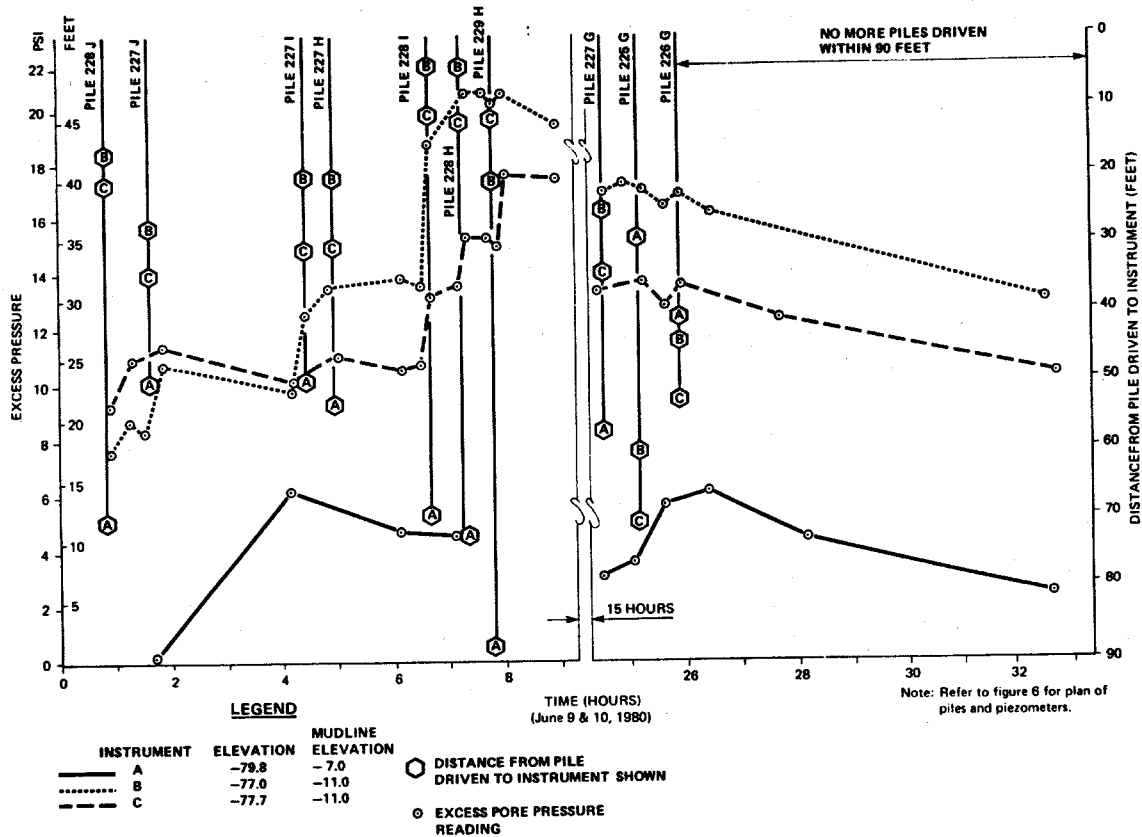
Figure 9. Pore pressures during pile driving (phase C).

Figure 9 presents data similar to Figure 8 for three piezometers of phase C. At this time, the contractor was driving 7-8 piles/day (one shift per day). The data indicate that piles driven 20-30 ft from the instruments increased the pore pressures to the 10- to 12-psi range. When pile driving came to within 10 ft of a piezometer, the pressures increased significantly and entered the red level.

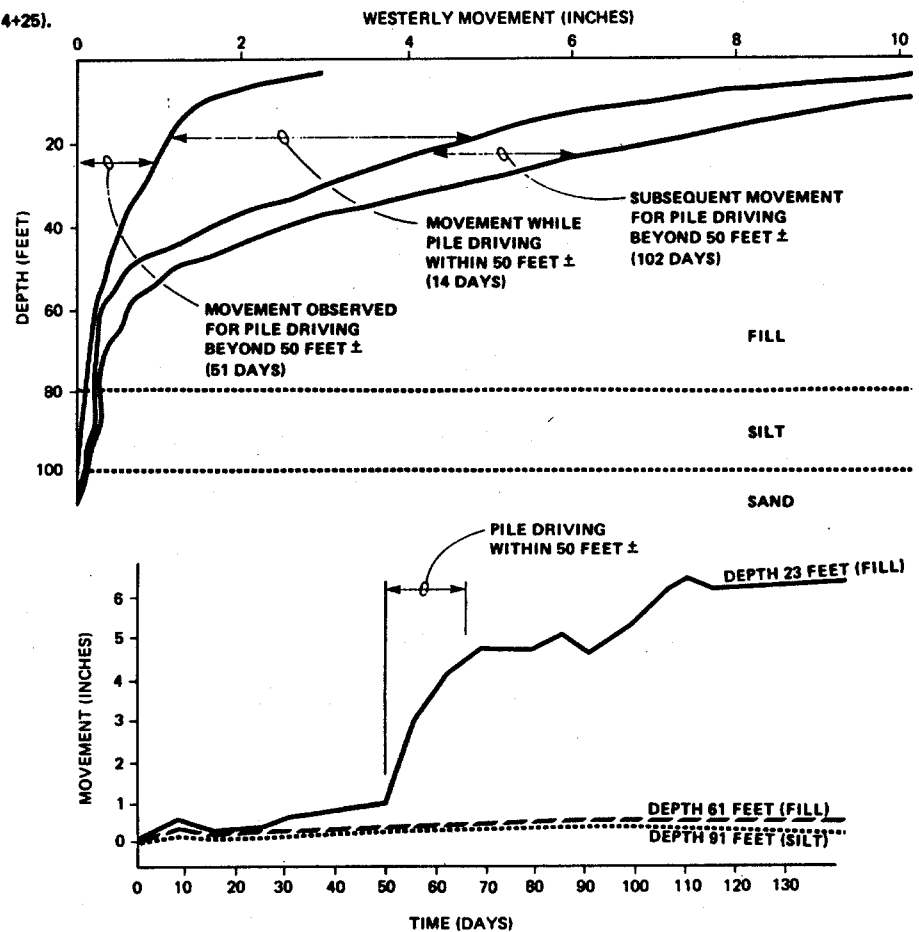
Figure 10. Slope indicator movement (station 4+25).

Figure 10 presents data from one typical slope inclinometer from phase B at station 4+25. No deep stability problems were observed in the deep silt layer, as shown by the small size and slow rate of movement. In the upper 20-40 ft of fill, large horizontal movements (about 5 in) and significant acceleration of movements were observed during pile driving within 50-60 ft of the inclinometer casing. After pile driving had moved away from the vicinity of the instrument location, the rate of movement decreased.

The indication in phase B piezometers that the effect of pile driving in the silt was local and did not extend beyond 30 ft (21.8 pile diameters) was confirmed by the phase B inclinometer observations, which showed only small movements in the silt layer (Figure 10).

The horizontal movements in the new fill shown in Figure 10 were considered a result of compaction of the fill from the pile-driving vibrations. The movements, although large, were not considered to indicate instability of the embankment and confirm the densification effect of driving displacement piles into loose granular materials.
