SY, A., SIU, D., and FELLENIUS, B. H., 1992. A case history of prestressed concrete splice problems. Proceedings of the Fourth International Conference on the Application of Stress-Wave Theory to Piles, Ed. F.B.J. Barends, DenHague, September 21-24, 1992, A.A. Balkema, pp. 479-486.

A case history of prestressed concrete pile splice problems

ABSTRACT: Many problems were encountered with the mechanical wedge-type splices used for 380 mm square precast prestressed concrete piles installed at an industrial plant site. Many of the wedges were breaking during installation of the splices and after pile driving resumed following splicing. Dynamic monitoring of the piles and uplift loading tests confirmed that the problems were associated with cracked or damaged wedges. More ductile, annealed wedges were subsequently used and, while not completely satisfactory, they were found to perform better than the original more brittle wedges.

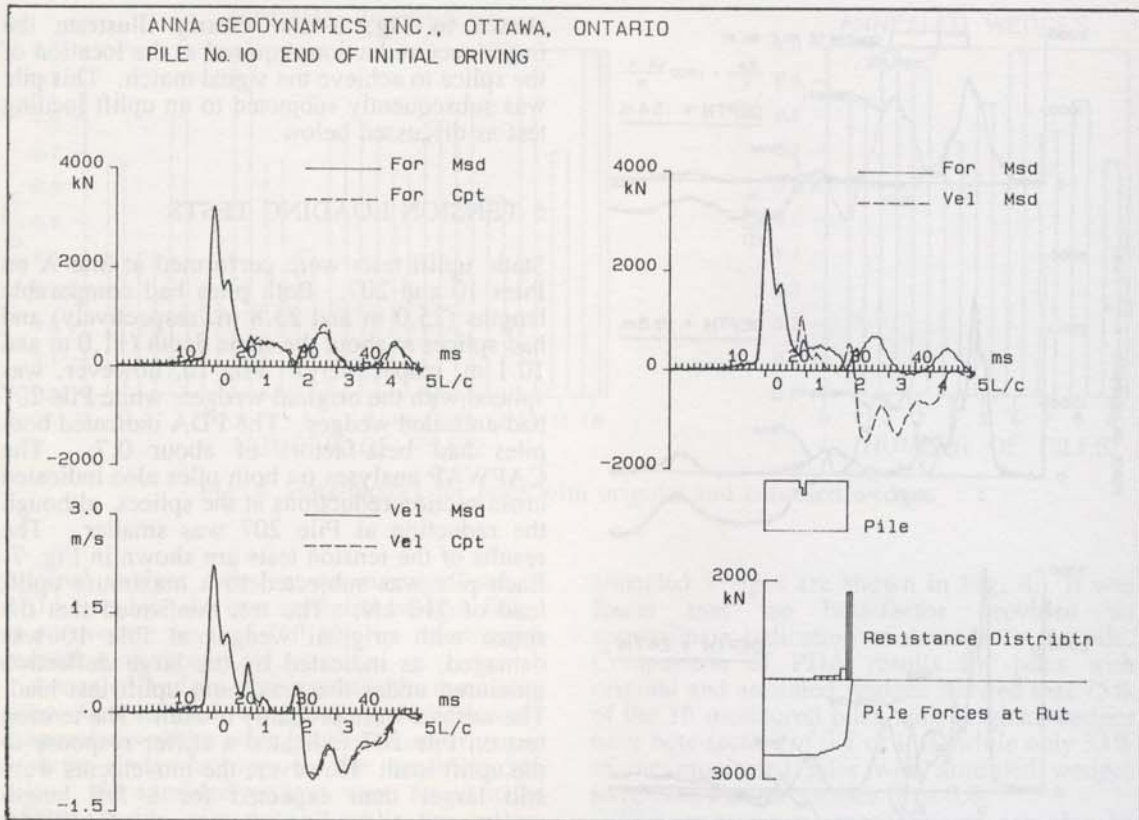
Fig. 6 CAPWAP analysis of Pile 10

shown in Fig. 6 and clearly illustrate the impedance reduction required at the location of the splice to achieve the signal match. This pile was subsequently subjected to an uplift loading test as discussed below.

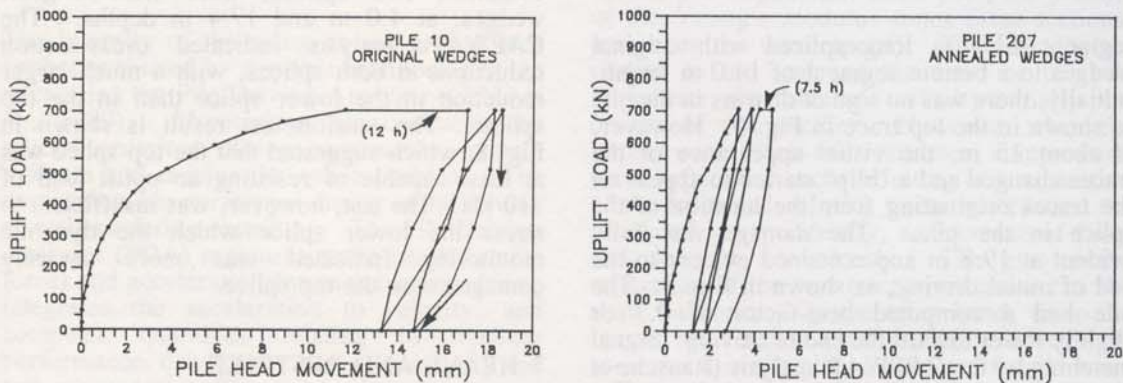
Fig. 7 Tension loading tests of Piles 10 and 207 at Site A

Static uplift tests were performed at Site A on Piles 10 and 207. Both piles had comparable lengths (25.0 m and 23.8 m, respectively) and had splices at about the same depth (11.0 m and 10.1 m, respectively). Pile 10, however, was spliced with the original wedges, while Pile 207 had annealed wedges. The PDA indicated both piles had beta-factors of about 0.7. The CAPWAP analyses on both piles also indicated cross-section reductions at the splices, although the reduction at Pile 207 was smaller. The results of the tension tests are shown in Fig. 7. Each pile was subjected to a maximum uplift load of 710 kN. The test confirmed that the splice with original wedges at Pile 10 was damaged, as indicated by the large deflection measured under the maximum uplift test load. The wedges were probably broken. The tension test on Pile 207 indicated a stiffer response to the uplift load. However, the movements were still larger than expected for a full length undamaged pile. Furthermore, the CAPWAP analysis indicated that the splice plates were not in full contact during driving.

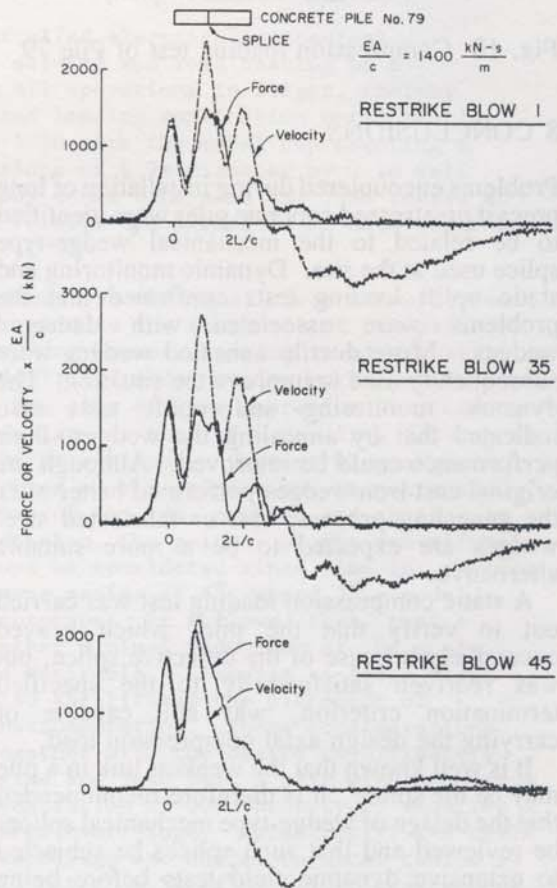
Fig. 9 Wave traces during restrike of Pile 79

In order to check the compressive capacity of those piles with defective splices which separated due to ground heave and which were brought back into contact, a static compression test was carried out on Pile 79 at Site A. Pile 79 was driven with the original wedges to a final depth of 25.5 m, but it had heaved 240 mm due to driving of adjacent piles. The PDA confirmed that the upper and lower pile segments had separated at the splice location, but were brought back to contact when the pile was restruck. Fig. 9 shows the recorded wave traces from several blows of restrike with a drop hammer. The wave traces clearly show that the two pile segments closed after some

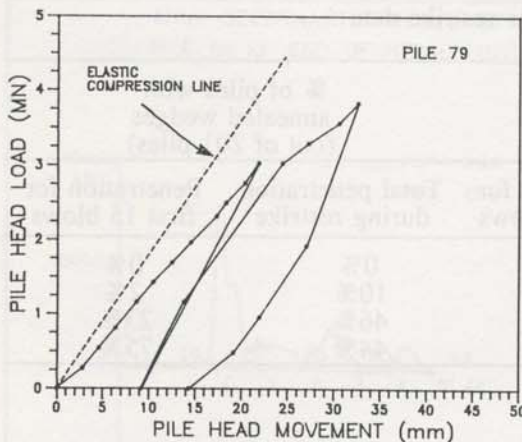
Fig. 10 Compression loading test of Pile 79

35 blows of restriking. The results of the subsequent axial compression loading test on Pile 79 are shown in Fig. 10. The pile did not reach failure. A Davison offset limit load of 2.9 MN can be determined from the load-movement data. The Young's modulus used to calculate the elastic compression line in Fig. 10 is 32.3 GPa.

A static compression loading test was carried out to verify that the pile, which heaved excessively because of the defective splice, but was redriven satisfactorily to the specified termination criterion, was still capable of carrying the design axial compression load.
