Fellenius, B.H., Terceros, H.M., Terceros, A.M., Massarsch, K.R, and Mandolini, A., 2019. Static response of a group of 13 piles tested simultaneously. 4th Bolivian International Conference on Deep Foundations, Santa Cruz de la Sierra, Bolivia, May 23-24, 13 p.

Static response of a group of 13 piles tested simultaneously

ABSTRACT. Static loading tests to plunging "failure" were performed on a single pile and a group of 13 piles in a loose to compact silty sand. The piles were 300-mm diameter, 9.5 m long, pressure-grouted, bored piles with an expanded pile toe, a 400 mm wide Expander Body (EBI). Each pile had a bidirectional cell placed just above the EBI at 8.3 m depth. The tests comprised a bidirectional test on the piles with the pile group cells activated via a common pressure pump, thus, ensuring that equal load was applied to all piles, allowing each pile to move individually. The pile group responded as a pier with shaft resistance acting mostly along the perimeter piles or along the pier circumference rather than as 13 single piles. A rigid cap was then constructed over the piles and a head-down test performed. Also in the head-down test, the developed resistance was mainl

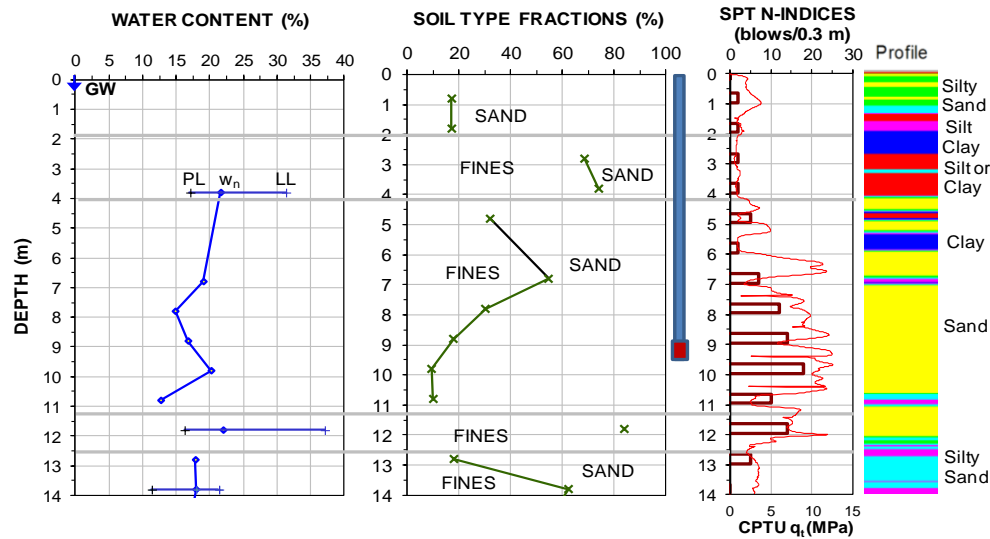
Fig. 1 Soil profile at BH-E2.

The site investigation at the B.E.S.T. site, notably the CPTU sounding results, showed the soil profile to consist of essentially two soil layers: an upper 6 m thick layer of loose silt and sand on compact silty sand. The CPTU pore pressure measurements indicated a groundwater table at or near about 0.5-m depth and a hydrostatically distributed pore pressure. Figure 1 shows a diagram compiling borehole information, SPT N -indices, and the CPTU cone stress, q_t , to 14 m depth. The CPTU was pushed to 22 m depth and Figure 2 shows all the results.

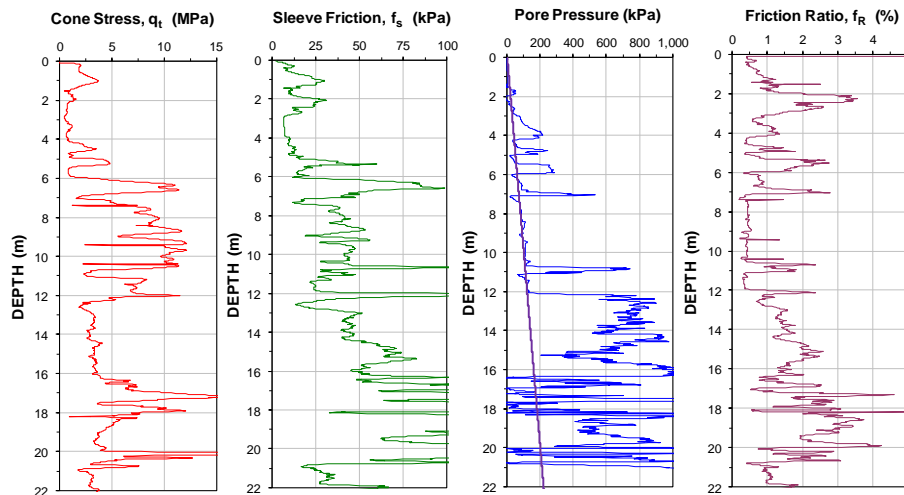
Fig. 2 CPTU sounding diagram, CPTU E2.

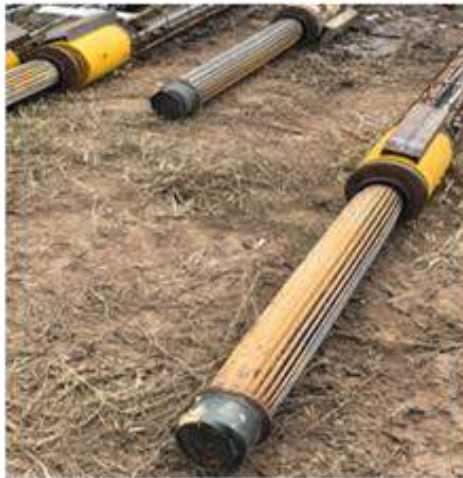
Fig. 3 Photo of the EBs and BD before pile construction.

The Expander Body and its use is described by Terceros and Massarsch (2014). Figure 3 shows a photo of the EBI and BD (placed immediately above the EBI) before insertion into the pile shaft. The BD was connected to the pile reinforcement cage. The separation of the BD and cage from the EBI was designed to occur at the bottom of the BD.

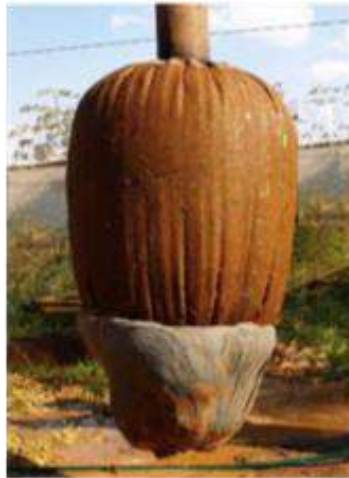
Fig. 4 Exhumed EBI.

Figures 4 and 5 show photos of an exhumed EBI and one expanded in air (models EBI612 and EBI815, respectively), with the numbers indicating the diameter of a freely expanded unit. Figure 4 shows a photo of an exhumed EBI (EBI612) with post-expansion grout material and an in-air expanded EBI (EBI815). The grout volumes and injection pressures used for the expansion of the EBIs of the 14 test piles were very similar for the piles. The averages were 102 L and 4.0 MPa, respectively.

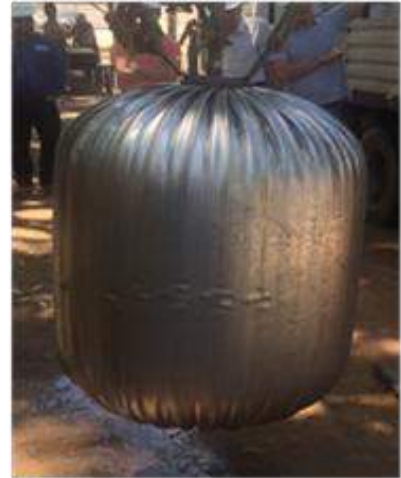
Fig. 5 In-air expanded EB

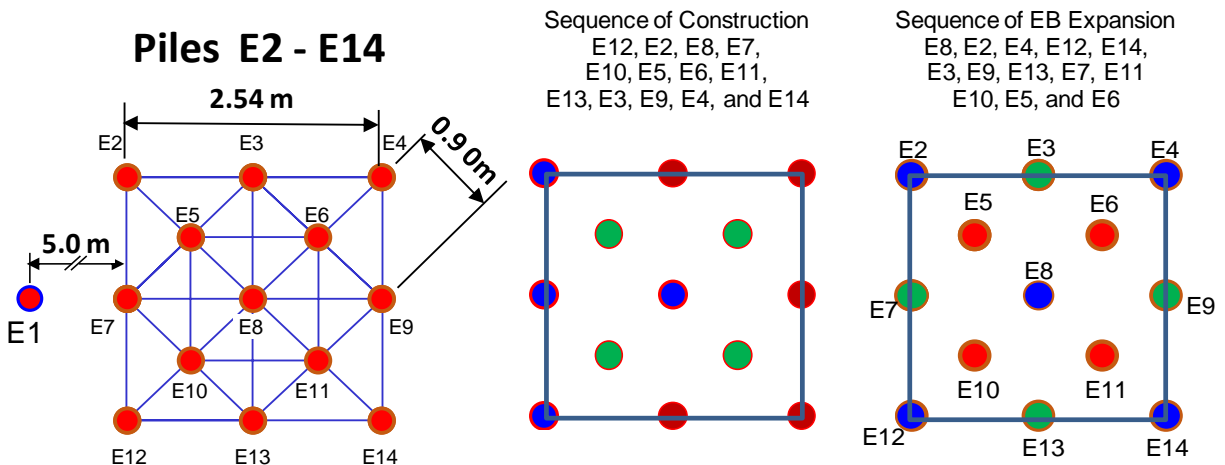
Fig. 6 Pile locations and sequence of construction and EB expansion.

The piles were installed at a 3 pile-shaft diameter, center-to-center spacing, 0.90 m in the configuration shown in Figure 6. The spacing corresponds to an 11 % total footprint ratio (nominal total pile cross section area at the ground surface over group footprint area).

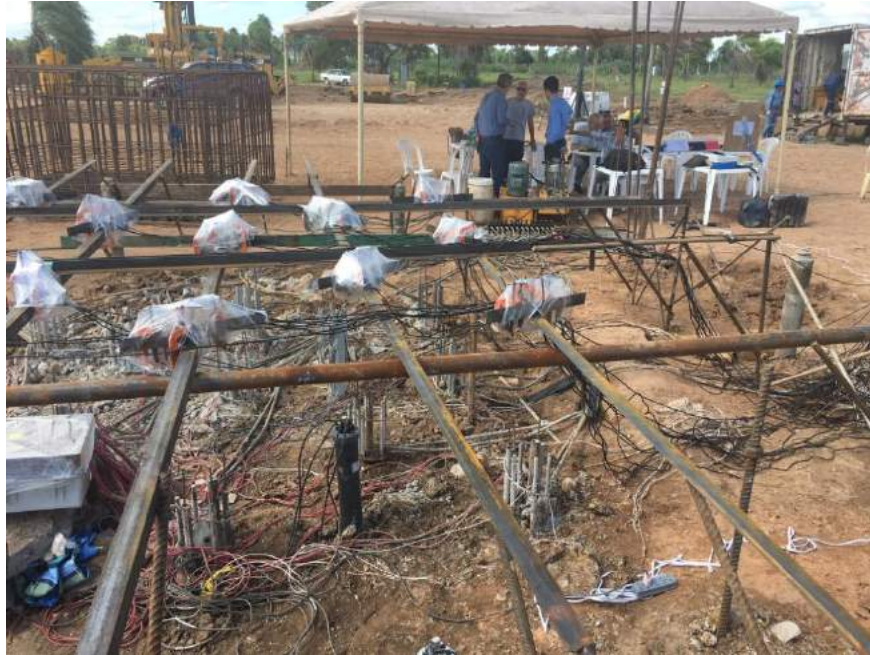
Fig. 7 Photo of frame for recording pile movements at Phase 1 test on Piles E2 - E14.

Phase 1 loading tests were performed by engaging the BD cell to push the pile shaft upward with the EBI providing the necessary reaction force. The BD cells in the group piles were connected to a common pump to have all group piles, Piles E2 - E14, activated with equal load per pile. The pile heads were unrestrained and the pile head movements were measured individually. Figure 7 shows a photo of the arrangement for recording the individual pile-head movements of the E-Group. The measurements included monitoring the ground surface movements at 10 points along the perimeter and in the interior area of the group. The test schedule, same for the single pile, Pile E1, and the group piles, Piles E2 - E14, consisted of applying equal load increments of 50 kN/pile every 10 minutes and recording the movement of the pile head until it became excessive.

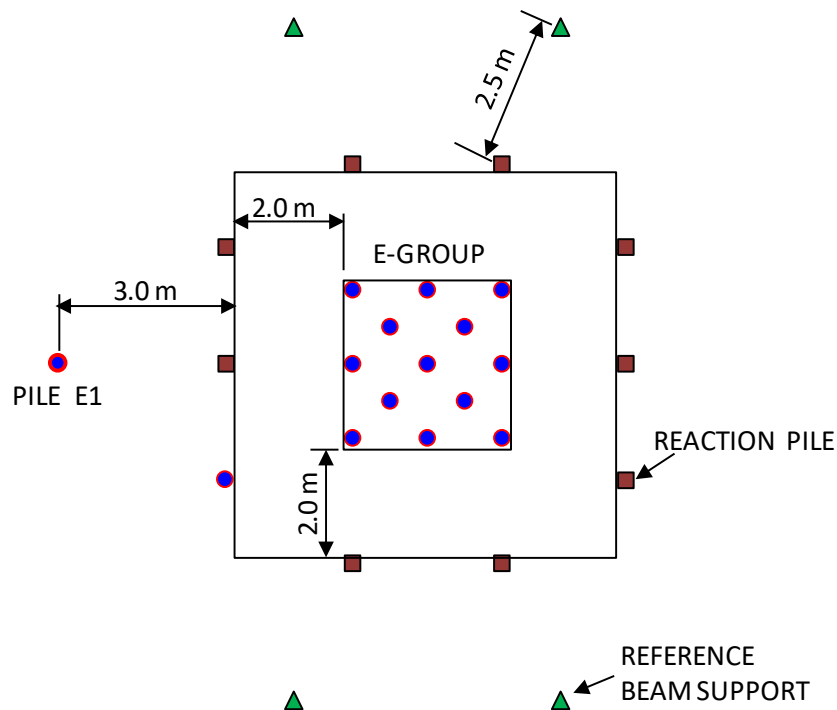
Fig. 8 Locations of test piles, reaction piles, and reference beam support at the E-Group.

The Phase 2 head-down test was performed by jacking against reaction piles placed at a pile surface-to-surface distance of 2.0 m or more away from the nearest test pile, Figure 8 shows the locations of piles and reference beam support for the E-Group. The reaction piles were installed after completion of the tests on Pile E1.

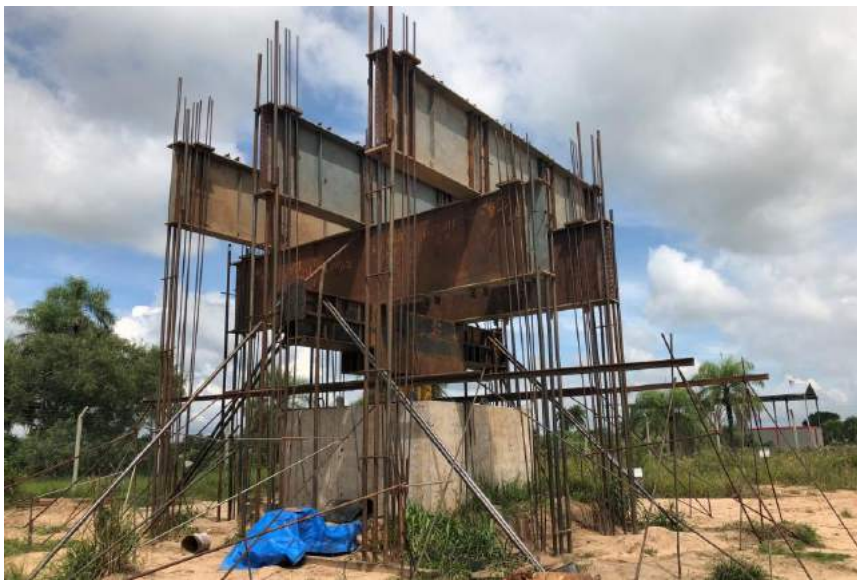
Fig. 9 Photo of set-up for head-down test on the E-Group.

To arrange for the Phase 2 head-down test on the pile group, a rigid, rebar-reinforced pile cap with a 3.5 m square base and 1.8 m height was cast on the group piles. Before forming and casting the cap, a 0.5 m compacted fill was placed on the ground over a 7.5 m square area centered around the test pile. The fill sides sloped 1(V):3(H), leaving a 0.5 m wide horizontal area around the pile cap. Figure 9 shows a photo of the Phase 2 set-up.

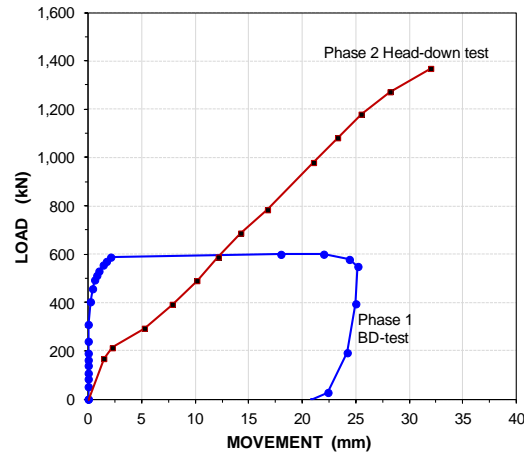
Fig. 10 Pile E1: Phase 1 BD-test and Phase 2 head-down test.

Figure 10 shows the measured Phase 1 load-movement of Pile E1 upper pile length and the Phase 2 head-down test on the pile. The pile response to the applied BD load was quite stiff with very small movement, about 1 mm, measured for the first about 500 kN applied load. This, indicates the presence of residual compression force in the pile at the start of the test. Beyond 600 kN load and 2 mm movement, the response went into plunging. The figure also shows the result of fitting an effective stress analysis and a hyperbolic t-z function with a function coefficient of 0.0099 ($1/Q_{100}$ %) to the measured curve. An effective stress proportionality beta-coefficient, β , was applied to 1.0 m pile elements, ranging from $\beta = 0.4$ at the ground surface to $\beta = 2.0$ at 6 m depth, which value was then kept to the BD depth. The UniPile5 software (Goudreault and Fellenius 2014) was used for this back-calculation.

PILE E1. The Phase 2 head-down test on Pile E1 comprised adding 50-kN increments every 10 minutes. When the load reached 1,400 kN, the pile head broke and the test was over (c.f., Figure 10).

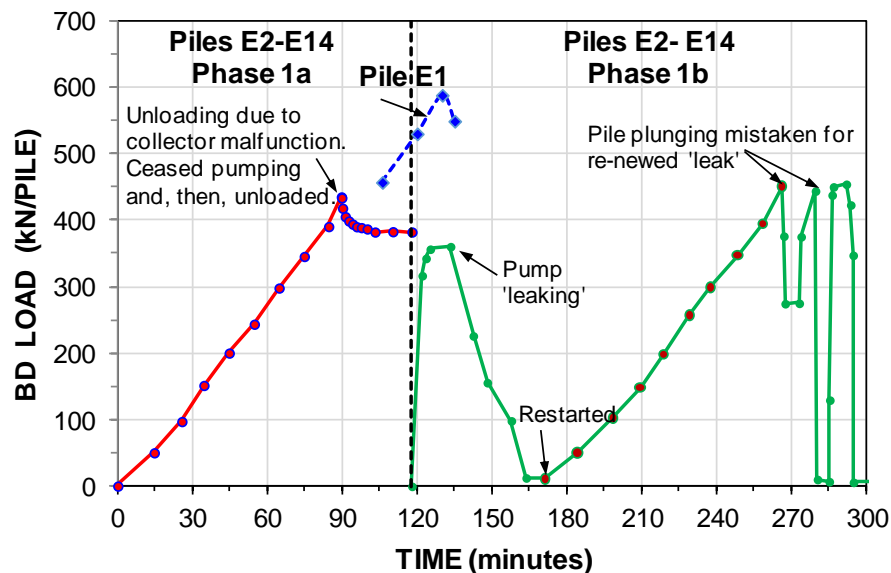
Fig. 11 Phases 1a and 1b, Loading sequence for Pile E1 and Piles E2 - E14.

PILES E2 - E14. The static loading test on the pile group, Piles E2 - E14 started on April 28, 2017, applying the same schedule of loading as used for the Phase 1 single pile test. Nine load increments into the test, it was realized that the data collector was not recording properly and this triggered an unloading of the test to restart with a functioning collector. Unfortunately, on reaching zero BD load, the cells were let to drain further, which allowed the remaining force in the pile to contract the BD at free-draining, i.e., no measurement of force. The test was then restarted three days later from assumed zero BD load and with resetting of all displacement gages. Figure 11 shows the load/pile response of the group piles versus time applied comprising the now two-part loading sequence, Phases 1a and 1b. The load-movement measured for Pile E1 is included for reference. Shortly after re-starting the test (Phase 1b), it was found that the pump had sprung a leak preventing it from maintaining pressure. The BDs were then unloaded to almost zero pressure, whereupon the manifold was locked from further release of hydraulic pressure and the pump was repaired and the test re-started (Phase 1b). No similar records of force and movements were made for the single-step unloading of the BD in Phase 1a. The Phase 1b records are plotted with a starting movement equal to the last reading of Phase 1a.

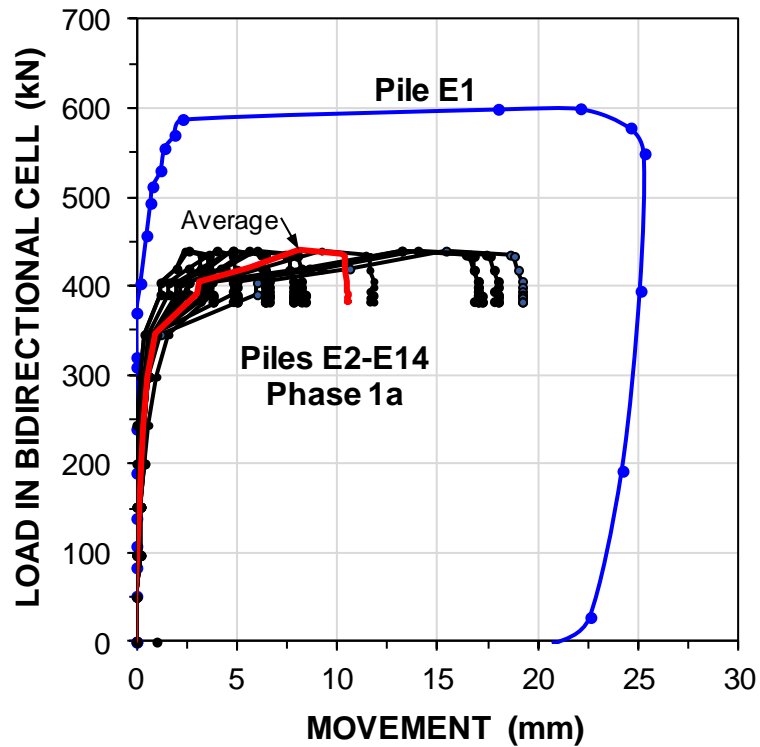
Fig. 12 Phase 1a Piles E2 - E14 and Phase 1 Pile E1: Pile head upward load-movements.

Figure 12 shows the load-movements of Piles E2 - E14 and, for reference, that of Pile E1.

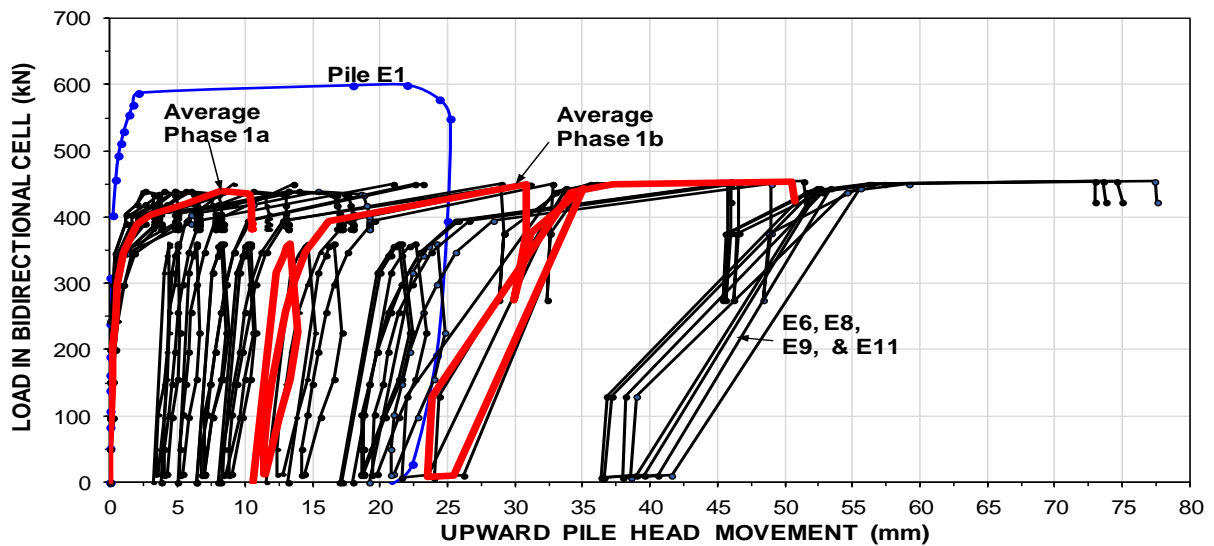
Fig. 13 Pile E1 and Piles E2 - E14. Pile head upward load-movements.

Figure 13 shows the full Phase-1 load-movements of Piles E2 - E14. The response of the 13 piles was very similar to that of the single pile: initially quite stiff and plunging after just a few millimetre of movement. However, the plunging load per pile was only about 70 % of the plunging load measured for Pile E1—435 kN versus 600 kN.

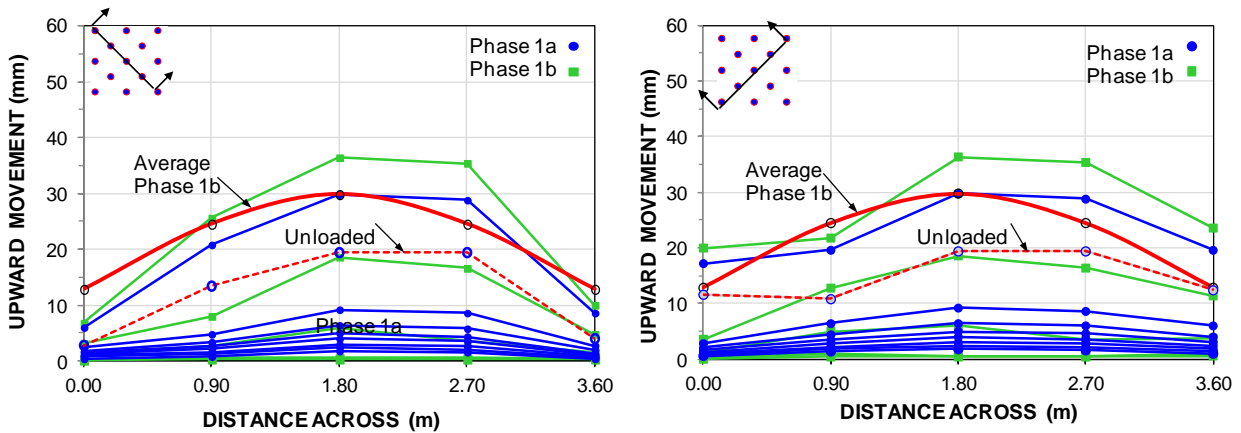
Fig. 14 Upward movement of the pile heads along the diagonals, Phases 1a and 1b.

Figure 14 shows the upward movement of all pile heads, including the net movements after Phase 1b unloading (limited to the four piles indicated to minimize the interference of the curves). Both graphs include the average of all pile head movements measured in Phase 1b for the maximum load. The measurements showed that the center pile moved about three times more than the perimeter pile.

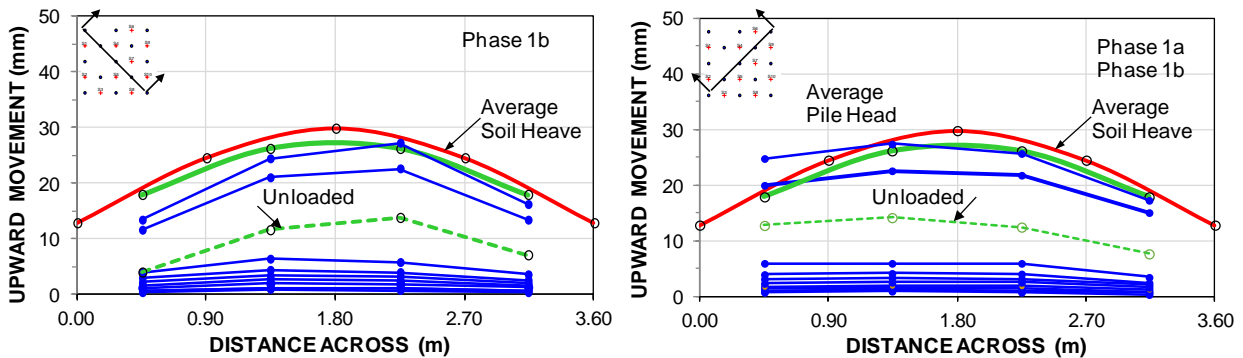
Fig. 15 Upward movement of the ground surface within the pile group. Phase 1b

Figure 15 shows the ground-surface upward movements across the diagonals (including net movements after Phase 1b unloading) and average (at maximum load) ground surface heave, as measured in ten anchors for Phase 1b. The average (at maximum load) upward movement of the pile heads (c.f., Figure 13) is repeated for reference. The "zero" measurement is the start of the Phase 1b, the net effect of Phase 1a is not known. It would seem that the pile heads moved a bit more than the soil surface. However, this is misleading because the pile head movements in Phase 1a in unloading were not recorded and, as mentioned, the Phase 1a ground surface measurements were not recorded by the data collector. That is, the previous movements of the pile heads and the ground surface at the start of Phase 1b are unknown. The trend of the ground surface movements and that of the pile heads are the similar. In unloading after Phase 1b maximum load, the unloading movements were about the same for the pile heads and the ground surface. It would seem that the pile heads and ground surface moved more or less in unison.

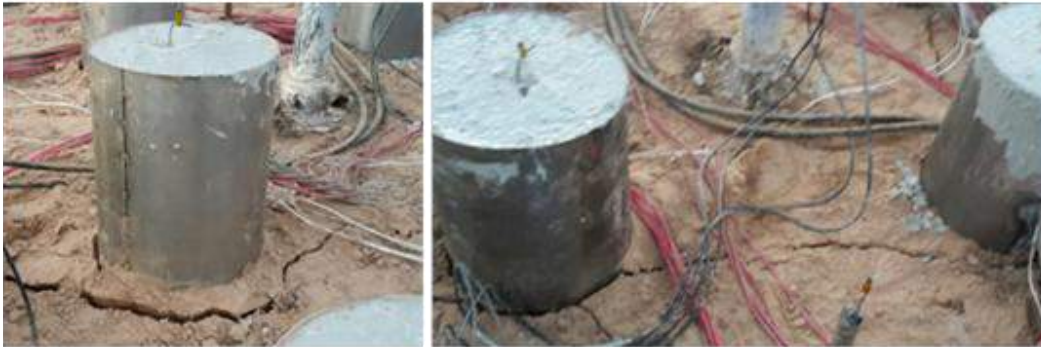
Fig. 16a Photographs of cracks in ground surface at a corner pile and at two side piles.

Figure 16a and 16b show photographs of piles and ground taken after Phase 1b unloading and show cracks in the ground surface around a corner pile and from pile to pile along the perimeter of the group. The observations suggest that the pile group moved in unison encompassing piles and in-between soil.

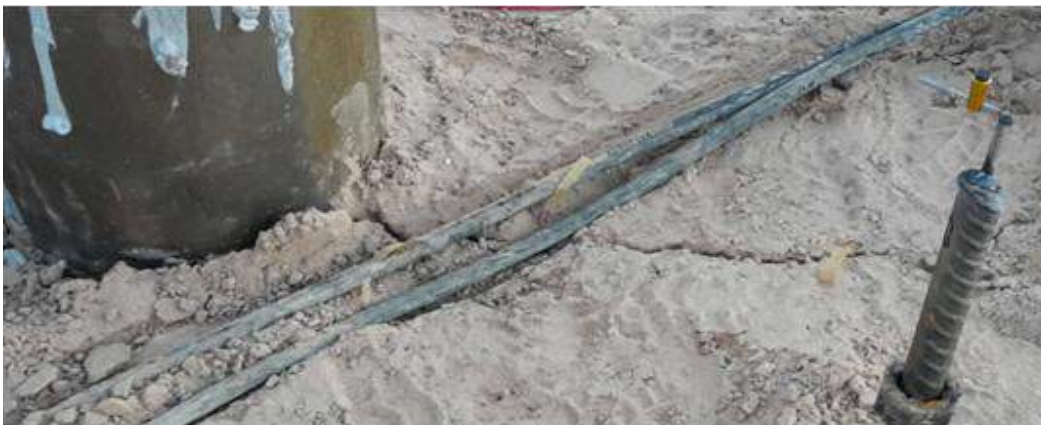
Fig. 16b Photographs of cracks in ground surface stretching from one pile toward the next along the side of the group.

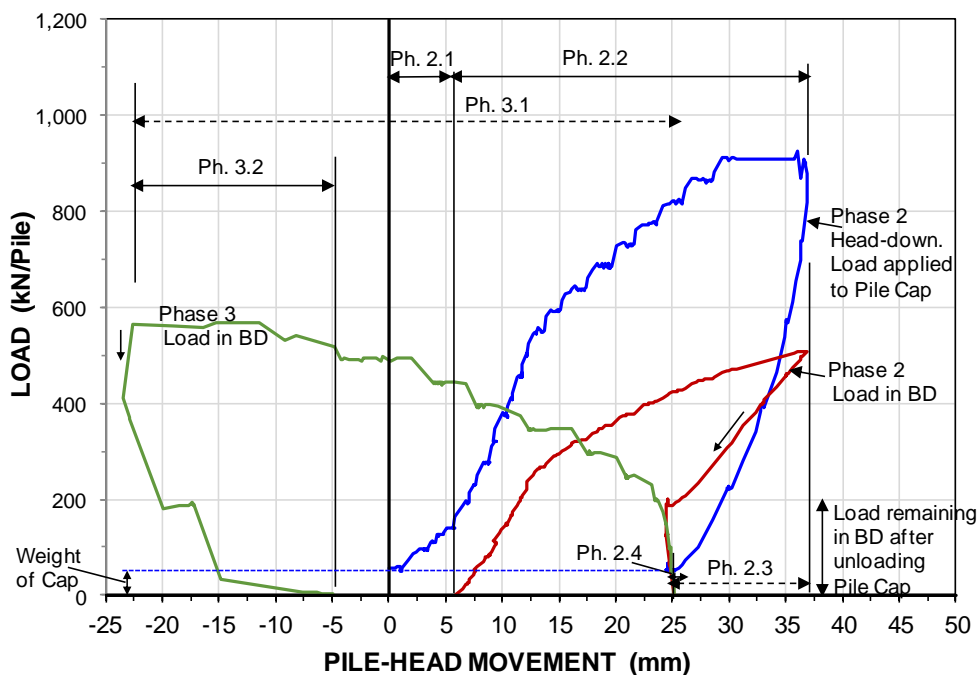
Fig. 17 E-Group: Pile-head load-movement records during Phases 2 and 3.

PILES E2-E14. The load-movement measured for the E-Group (Phase 2 head-down and Phase 3 BD tests) on the pile group is shown in Figure 17. The records shown are the load applied to the pile cap divided by the number of test piles (13) and the measured BD load (per pile). At the maximum load (910 kN/pile), the test was terminated because the pile-head movement started to increase coinciding with signs of yielding of the reaction system.

It is interesting to see that after complete unloading of the pile head, significant force was maintained in the pile between the BD and the pile head. In the subsequent unloading of also the BD, only a very small increase of movement (downward) occurred.

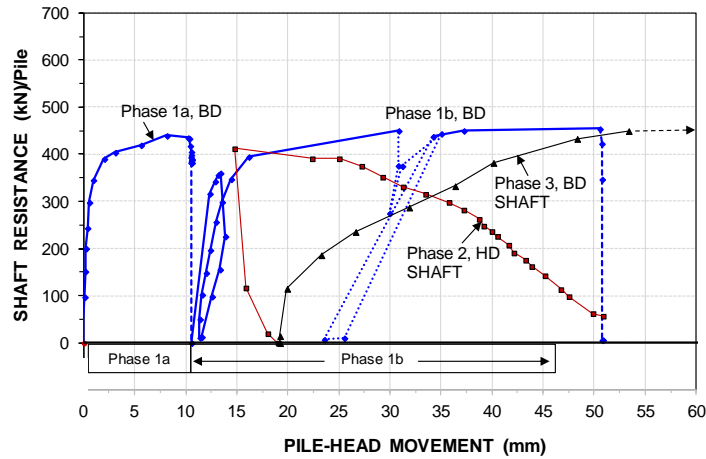
Fig. 18 Shaft resistance measured in Phases 1 through 3.

Figure 18 shows shaft resistance versus pile-head movement for the three test phases of Piles E2-E14. The results indicate that the maximum shaft resistances, which indicated a plastic response, was equal in all three phases. However, the movement to mobilize the plastic response in Phases 2 and 3 was much larger than in Phase 1, which is likely due to the fact that the movement directions were reversed between the tests.

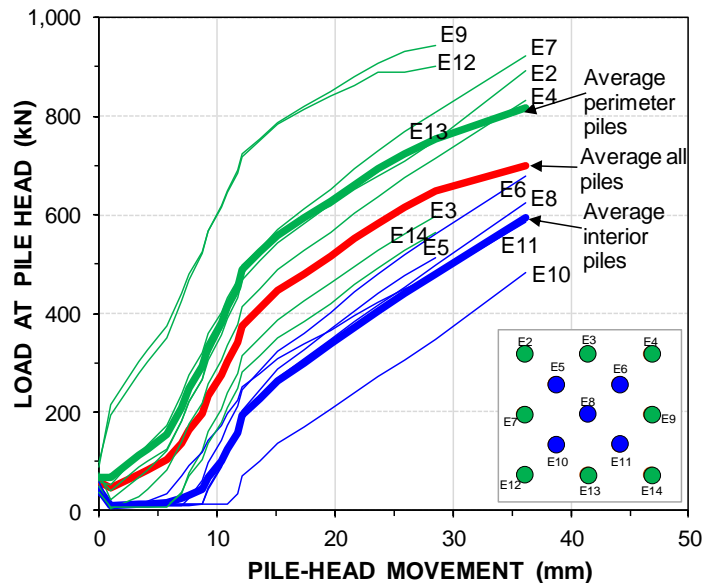
Fig. 19 E-Group Phase 2 Loads at the pile head; individual and averages.

Phase 2 test results of the E-Group are particularly interesting. Because of the rigid pile cap, all pile heads movement were equal. Figure 19 shows the load-movements of the individual piles together with the average load-movement of the perimeter and interior piles, as well as the average of all piles. For equal load, the interior piles moved much more than the perimeter piles, much as they had done when, in Phase 1, the pile heads were unrestrained and the load, same for all piles, was induced from the BD (c.f., Figures 13 and 14). For equal movement, the load on the perimeter piles was much larger than on the interior piles, that is, the perimeter piles mobilized a much larger resistance for equal movement.

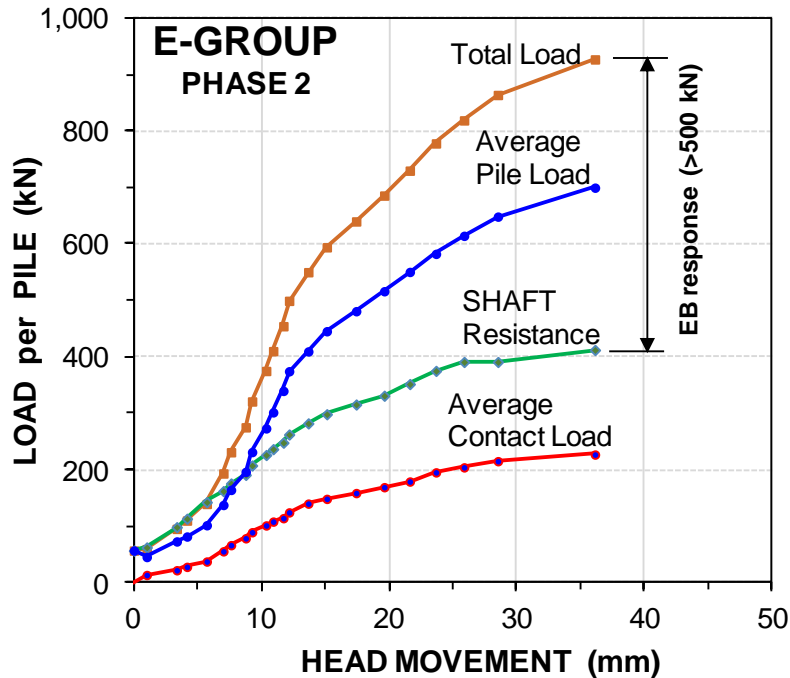
Fig. 20 E-Group Phase 2; Loads vs. movements.

Figure 20 compares the load-movements of the total load applied to the pile cap, the average pile-head loads, the shaft resistance between pile head and BD level, and the average contact load. The average contact load is the difference between the total load and the pile-head load. The average shaft resistance was determined as the total load (load/pile) minus the BD-load/pile. When assuming that the average axial strain of compacted fill under the raft would be the same strain as in the in the piles ($\approx 500 \mu\epsilon$), the contact load correlated to an about 200-MPa E-modulus of the fill—a very high value even when considering that the sand is compacted and confined.
