Wick Drains and Piling for Cai Mep Container Port, Vietnam

GeoMEast 2018 International Congress, Cairo, Egypt, November 2018

Bengt H. Fellenius[1], Dr.Tech, P.Eng.

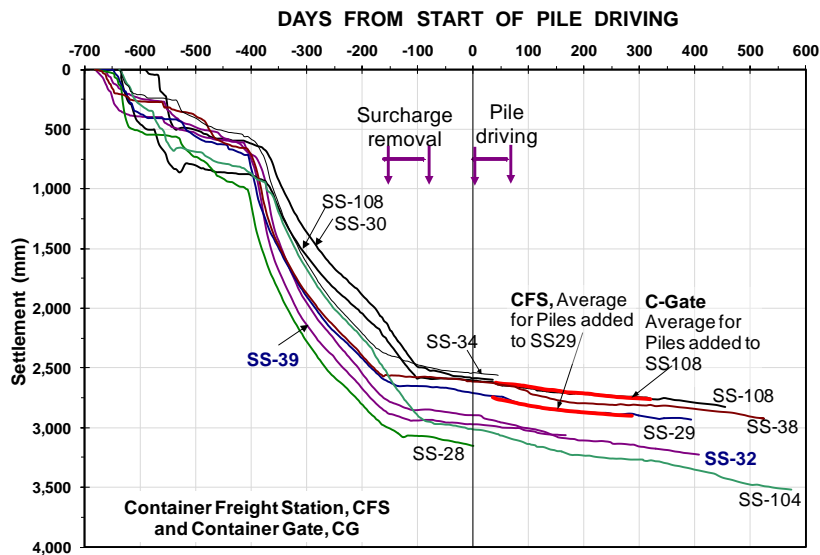
Fig. 9   Ground surface and pile settlements

Several SS-plates were damaged or had to be removed during the construction. However, two SS-plates within each building footprint (Plates SS-28 and SS-29, and SS-108 and SS-30) were functioning and contiguously monitored as were settlement plates outside and near the buildings. The figure also shows the average settlement of the pile heads in the two buildings as superimposed on the settlements measured for SS-28 and SS-108 (these results are discussed in regard to Figure 14).

The total settlement during the consolidation period differs by about 1.0 m between the various SS-plates. The difference is mostly due to the mentioned fact that the monitoring started at different times after the fill had been placed near the plate. The trends immediately before and after the pile driving are quite similar.

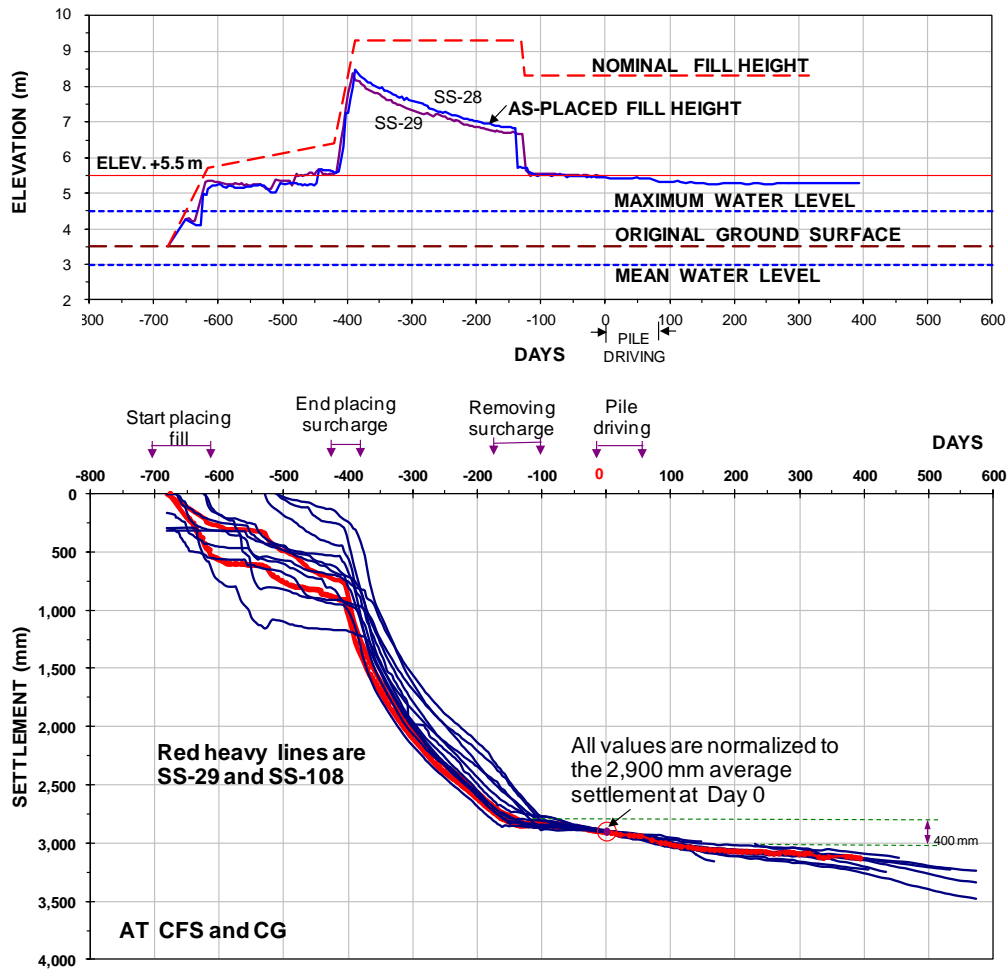
The average settlement at Day 0 (December 3, 2010) was 2.90 m. After removal of the surcharge at Days -160 through -80, within the building footprint, the settlement during the next about 400 days, to about Day 300, amounted to about 250 mm, about four to five times more than anticipated.

The settlement development after the removal of the surcharge is obvious if the settlements are referenced to the 2,900-mm average settlement at Day 0, as shown in the lower diagram of Figure 10. The upper diagram in Figure 10 shows the fill surface elevation measured at the two buildings (at SS-28 and SS-29). The line indicted as "as-placed fill" is the measured fill elevation plus the measured settlement. Note, the volume of soil and placed fill settled below the water table, which caused a reduction of the imposed stress, which has been considered in the settlement analysis.

Fig. 10   Fill and surcharge elevation and ground surface settlement

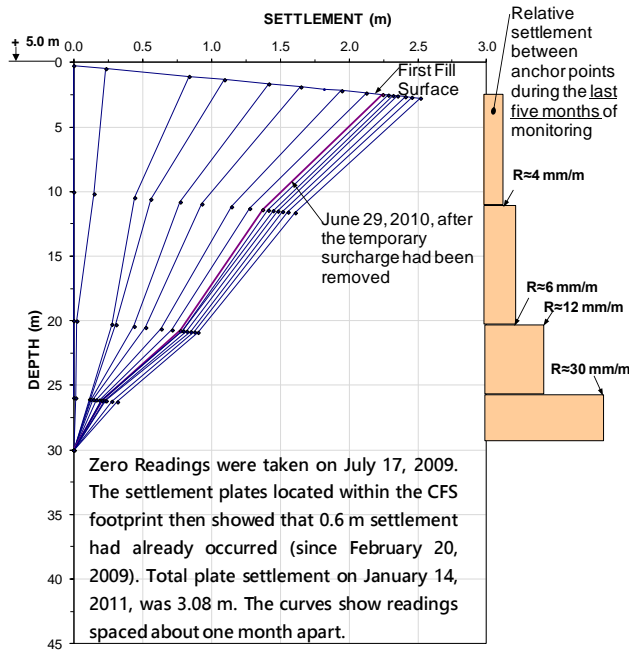
Figure 11 shows the settlement distribution with depth as measured at extensometer station, EXT-09 next to the CFS building at 10, 20, 26, and 30 m depths (original depths) from July 17 through January 14, 2011, i.e., Day -504 through Day 42, when the Ext-station had to be removed as it was in the way of the pile driving. The four settlements anchors were referenced to a presumed zero for the fifth anchor point placed at 30 m depth. The ground surface settlement (uppermost anchor) was found to agree approximately to the average of SS-28, SS-29, SS-33, and SS-34 for the same time period. At the installation of EXT-09, a 0.6-m ground surface settlement had already developed. The settlement distribution is almost linear from the fill surface to zero at 30 m depth. The sketch to the right in Figure 9 shows the relative settlement within the anchor points as measured during the last five months, i.e., after the removal of the surcharge. The sketch shows that below about 20 m depth, the ongoing relative settlement is twice to several times larger than above that depth. Evidently, consolidation continued below about 20 m depth after the removal of the surcharge.

Fig. 11   Settlement with depth July 17, 2009 through January 14, 2011

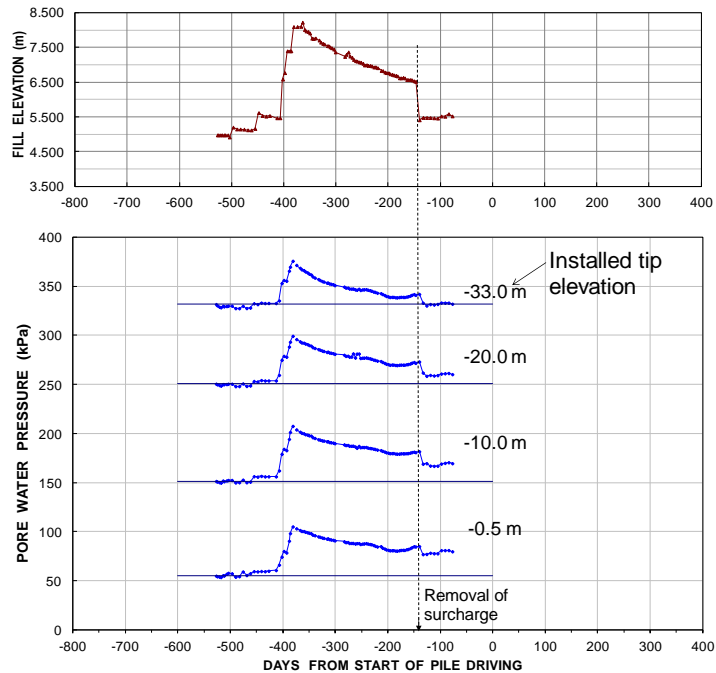
Fig. 12 Fill height and pore pressures measured between
Days -527 and -77 at the CFS building

Figure 12 shows the pore pressures measured at the CFS building at Elevs. -0.5 m, -10.0 m, -20.0 m, and -33.0 m from June 24, 2009, through September 17, 2010; Day -527 through Day -77 (until about three months after removing the surcharge). The figure also includes the fill height measured next to the piezometer station and shows that the first fill placement across the site (to Elev. +5.5) only resulted in a modest increase of pore pressure, whereas the subsequent placement of fill to full height gave a distinct pore pressure response. The modest initial response could be interpreted as an effect of a small preconsolidation margin.

The 5.8 m as-placed fill, which imposed a maximum stress of 100 kPa, resulted in a maximum pore pressure increase of 47 kPa, 50 kPa, 43 kPa, and 37 kPa measured at the four piezometers, respectively. The pore pressures appeared to have stabilized at about Day -200. When the surcharge was removed (about Day -150), the pore pressures reduced somewhat, and after removing the surcharge, the values of remaining pore pressure were 25 kPa, 20 kPa, 10 kPa, and 0 kPa, respectively, corresponding to about 50 %, 40 %, 20 %, and 0 % of the maximum values. The appearance of pore pressures remaining after the removal of the surcharge is due to that the measured pore pressures are referenced to the original piezometer depths. The pore pressures values from 33 m depth were probably affected by the proximity of the sand layer 2 m below and, also, by that the settlement at that depth must have been small.

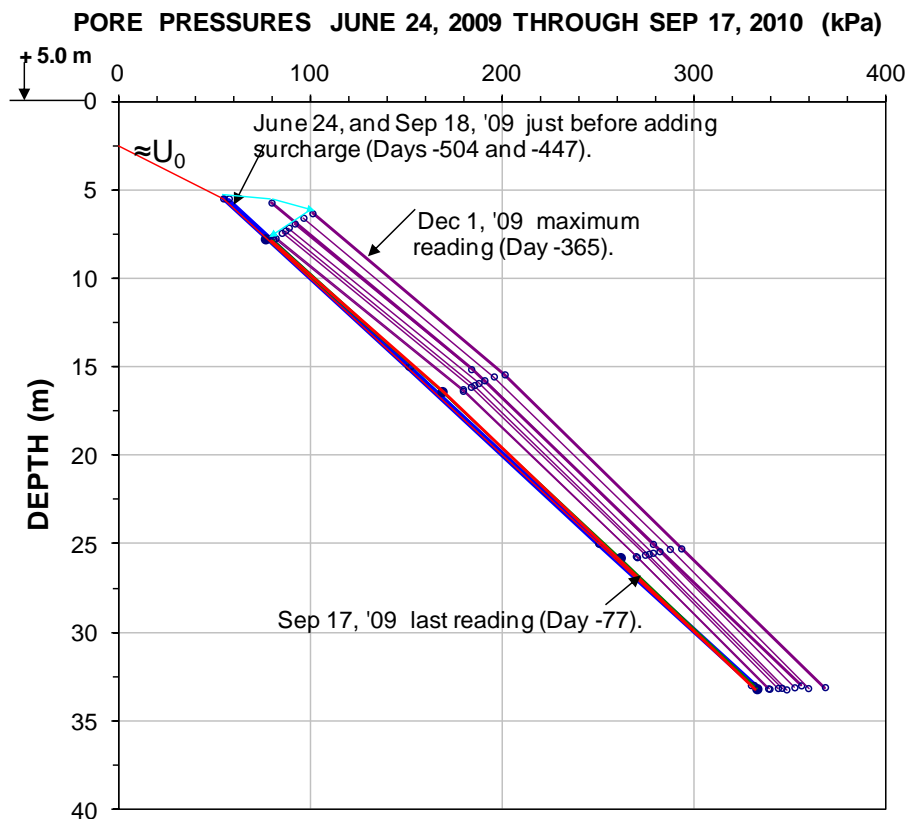
Fig. 13   Pore pressures versus depth with the piezometer tip adjusted to settlement

Figure 13 shows the pore pressure distribution versus depth. The pore pressures are adjusted to the settlement of the piezometer based on the Ext measurements. As seen from the Sep 17, 2009, 13 days before start of pile driving, the measurements appear to indicate that the pore pressures had returned to the original level and that primary consolidation had b`een completed. This differs from the indication from the settlement records (Figure 11) and it is possible that the actual settlement of the piezometer tips is smaller than evaluated from the Ext records.

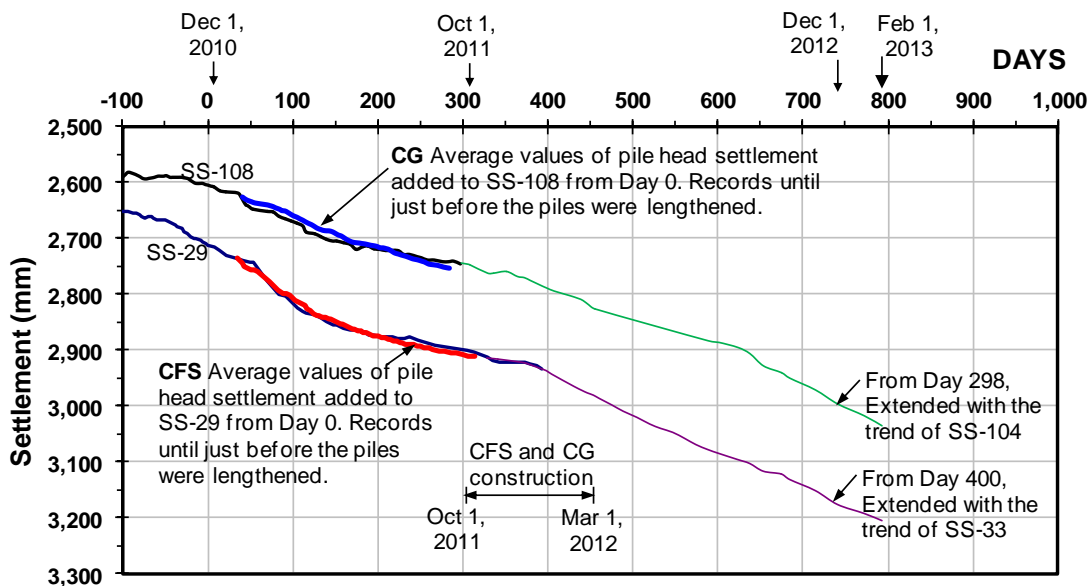
When all piles had been driven, the elevations of the pile heads were from then onward, Day 41, intermittently monitored. Figure 15 combines the settlement measured by SS-29 and SS-108 located within the footprint of the CFS and CG buildings with the pile head settlement values. The pile head settlements is plotted from setting the first reading equal to the settlement measured at the SS-29 and SS-108 plates on Day 41. The pile head monitoring had to be terminated when the building construction started because the SS-29 and SS-108 plates were in the way of the construction and had to be removed. The curves have been extended by the settlement trend measured in the still functioning plates, SS-33 and SS-104, outside the building footprints.

First to take note of is that the area continued to settle at a rate much larger than anticipated in the design; second, also the piles settled and settled at the same rate of settlement as that of the ground surface (the SS-plates). Particularly the latter was a surprising observation. It indicates that the settlement must have occurred below the pile toe levels, 18 m and 28 m for Buildings C-Gate and CFS, respectively, and that the consolidation was not completed in the lower portion of the profile—as also indicated by noted continued settlement below about 20 m depth (c.f., Figure 11). It would seem that the wick drain used was not suitable for the installation depth.

Fig. 15   Settlements of SS-29 and SS-108 located within the footprint of the
buildings and the average settlement of the pile heads from end of driving.

At this time in the construction of the port facilities, it became clear that the port area would continue to settle and that the piles would settle along with the ground. The settlement of the piled foundations of the CFS and CG buildings on the piles as initially driven, could exceed 500 mm; well in excess of acceptable values. To alleviate the situation, the piles for both buildings were extended and driven well into the sand layer below the clay to depths of about 40 m to 44 m in order to ensure that the neutral plane would lie below the clay layer and in non-settling soil. A 13 to 23 m lengthening was obtained by adding a pile segment to each initially installed pile, welding the end plates together, and then driving it into the sand below the clay, i.e.., to the 41-m embedment depth.

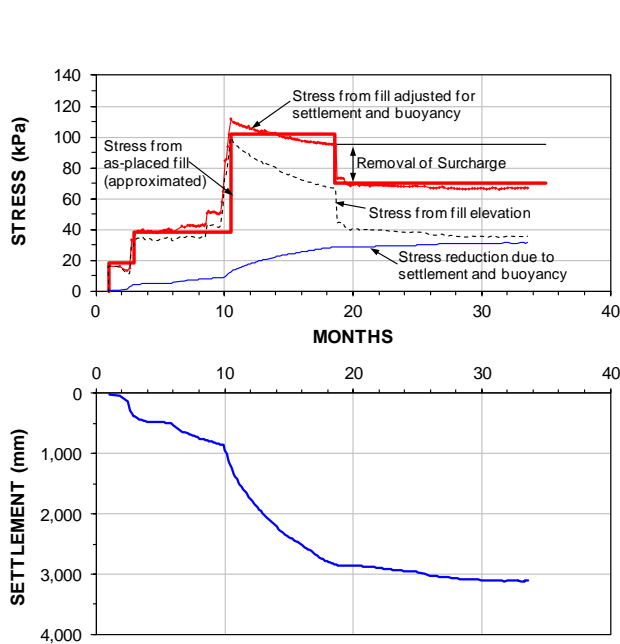
The loading input is illustrated in Figure 16, which shows the stress from the measured height of fill (SS-29) and the reduction of the fill height due to the soil and fill settling below the water table vs. months from the project start. The figure shows the correction of imposed stress for the loss of applied stress due to buoyancy. The stress adjusted for this effect is indicated in the figure and approximated to three loading and one unloading occasions. The lower diagram shows the settlement measured at settlement plate SS-29 in the CFS building.

Fig. 16 Actual loading and unloading stress and measured settlement vs. time.

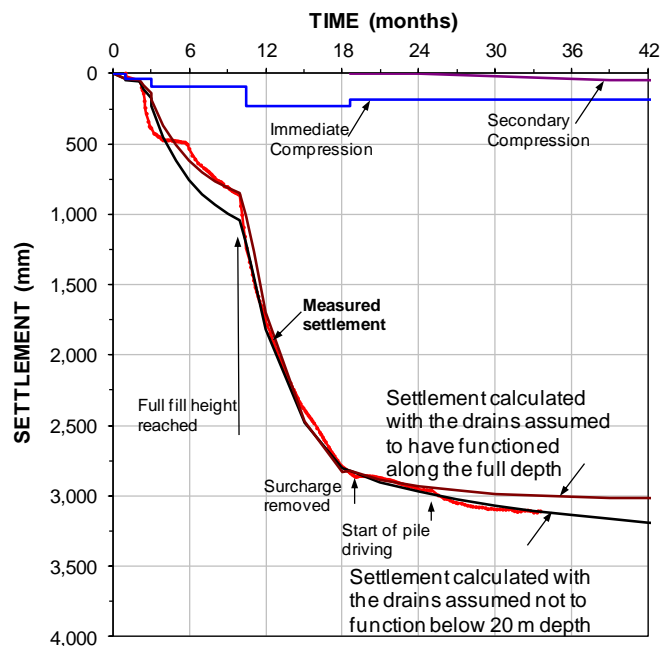
The calculations were carried out using the software UniSettle4 (Goudreault and Fellenius 2011) with input of stress events (c.f. Figure 16). Figure 17 shows the results of the calculations plotted together with the measured settlement versus time. The fit to the settlement measured up to the end of the consolidation period (24 months) was obtained for input of an immediate compression modulus number of 150 (j = 1) and a consolidation virgin modulus number, m, of 6 (j = 0.5) and reloading (unloading) modulus number, m_r, of 60 (j = 0.5). However, while the input resulted in a fit between calculated and measured settlement development for the first 24 months including six months after the removal of the surcharge, the fit was not good beyond this time. The calculations indicated that only little settlement should occur beyond the 24 months, but the plot of the measured settlement shows that significant settlement did indeed occur beyond 24 months.

Fig. 17 Results of back-analyses to fit measured settlements.

To achieve a fit also to the later development required the assumption that the drains did not work below about 20 m depth and that the consolidation between 20 m and 35 m depths followed vertical drainage. The calculations for below 20 m depth were, therefore, governed by the a vertical coefficient of consolidation, c_v. Reflecting the supposition that some function of the drains did remain below 20 m depth, the calculation assumed that the time for 80 % to 90 % consolidation would be 20 years for single drainage with a c_v of 30 $10^{-8} \ m^2/s$ (about 9 m^2/year).

Fitting to the delayed settlement in the lower 15 m of the soil profile showed that only about 30 % (300 mm) of the consolidation below 20 m depth would have occurred at 24 months after start as opposed to almost 100 %. That is, most of the consolidation below 20 m depth was still to develop after the surcharge removal.

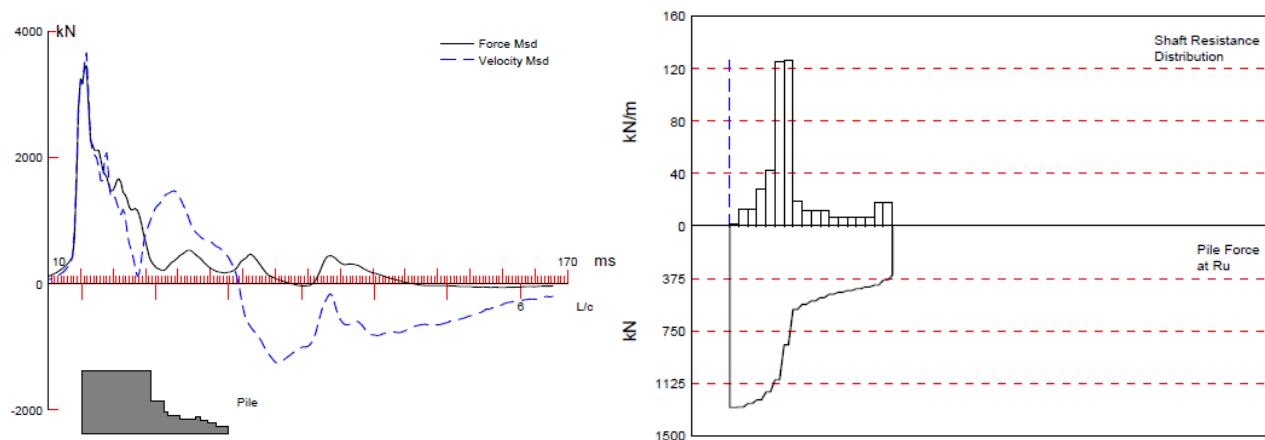
Extending the piles and driving them deeper raised concern for the structural integrity of the piles. However, the driving records did not indicate excessive variation of penetration resistance and the lengthening was declared successful. A few piles were subjected to dynamic testing with the Pile Driving Analyzer. The authors' post-project (2012) CAPWAP analysis of the test records showed low-integrity at different depths in the PDA-tested piles. Indeed, the PDA-tested piles were severely damaged below the original pile toe depth although not to the extent of a total break. Figure 18 shows the results of a CAPWAP analysis of a hammer impact on a lengthened pile when at 36 m depth. We believe that the results are typical of the lengthened piles.

Fig. 18. Results of CAPWAP analysis on a lengthened pile.
(Courtesy of AATech Scientific Inc.).

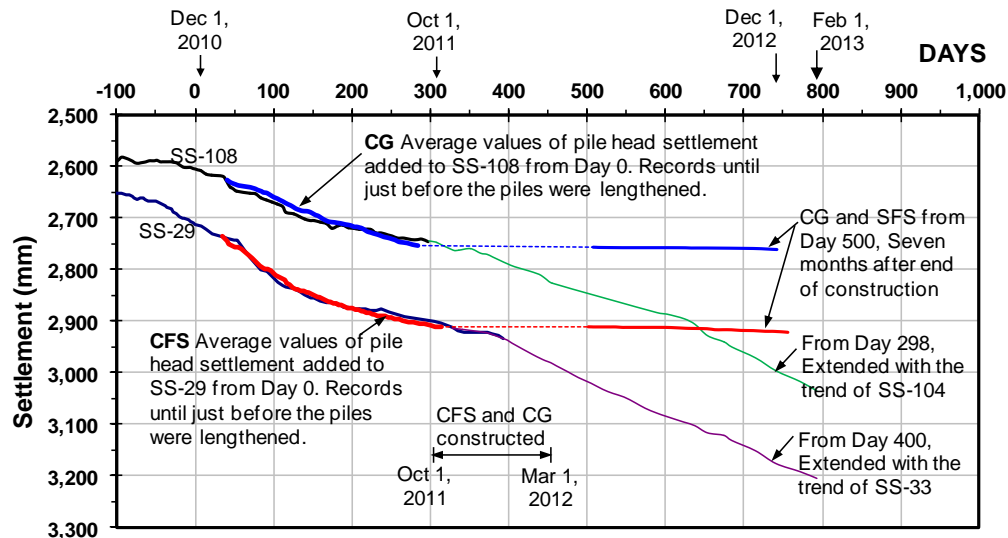
From about Day 500 onward, about 50 days after the ends of construction, the settlement of the CFS and C-Gate buildings was monitored over about nine months. The measured building settlements are shown in Figure 19 as added to the settlement records already presented in Figure 15. The average settlement over the nine months amounted to 6 to 11 mm, indicating a successful outcome of lengthening the piles. In contrast, the ground surface outside the building footprints continued to settle, indeed, the magnitude increased as the ground level of the area around the buildings was completed.

Fig. 19 Figure 15 with the results of monitoring the settlement of the C-Gate
and CFS buildings (starting two months after end of construction).

The indication that the redriving of the lengthened piles severely damaged the piles appears to contradict the observations that the foundation piles ceased to settle with the ground. However, settlement of a wide piled foundation is a function of the compressibility of the soil below the pile toe level (Fellenius 2018b). It is likely that the adding of the concrete sections to the soil below the original pile toe depth, considerably increased the average stiffness of the clay—decreased the compressibility—which resulted in reduced compression of the soil and, therefore, reduced foundation settlement.

Moreover, it is obvious that the significant settlement will continue to develop over the general container storage area will. To maintain the ground elevation and protect the site from the seasonal flooding will require placing additional fill, which will cause additional settlement. Because of the presence of the wick drains, functioning as they are in the upper 20 to 25 m depth, the subsequent consolidation and, therefore, new maintenance work at the site of the port area, will be frequent.
