## Wick Drains and Piling for Cai Mep Container Port, Vietnam

**ABSTRACT** Cai Mep Port is a new container terminal along the Thi Vai River in the Mekong delta approximately 80 km southeast of Ho Chi Minh City, Vietnam. The soil profile consists of about 35 m thick soft, deltaic silty clay deposited on dense to compact sand. The conditions required up to 10 m of preconstruction fill to raise the ground by 2.5 m and included a 7.5 m of surcharge kept on for about six months. The settlement was accelerated by means of wick drains at a spacing of about 1.2 m. The settlements were monitored and amounted to about 3.5 m. After removal of the surcharge, 0.4 m square precast concrete piles were driven to depths ranging from 18 through 30 m to serve as piled foundation of the Port buildings. The monitoring showed that the area and the piles continued to settle after the removal of the surcharge, which was due to the wick drains not functioning below about 20 m depth. The measured settlements and the adopted remedial solution are discussed.

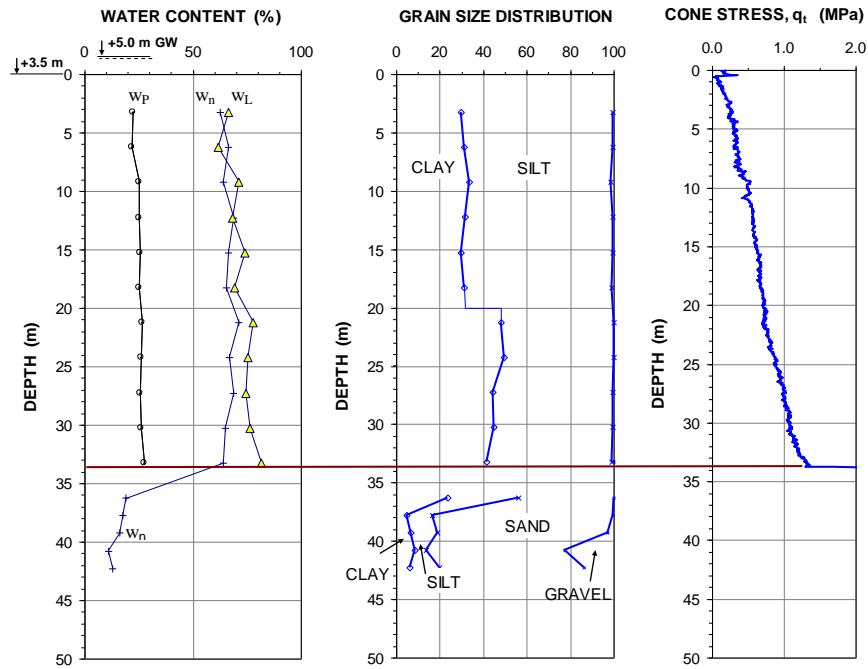
Fig. 2 Consistency limits, grain size distribution, and CPTU cone stress

The soil profile at the site consists of about 30 to 40 m of clay and silt deposited on sand with trace clay and silt. Figure 2 shows the distribution of water content and consistency limits. Total saturated density is about  $1,600 \text{ kg/m}^3$  throughout the clay (from  $w_n = 66\%$ ). The saturated density of the sand below the clay is  $2,100 \text{ kg/m}^3$  (from  $w_n = 19\%$ ). Figure 2 also shows the grain size distribution and the distribution of cone stress in the clay from a CPTU sounding made before the construction start.

The CPTU sounding cone-stress diagram indicates the soil deposit to be soft throughout. The vane shear strength (not shown in Figure 2) ranges from about 10 through 15 KPa at 2 m depth and increases approximately linearly to about 50 KPa through 80 KPa at 30 m depth, characterizing the clayey silt as soft to a depth of about 20 m and firm below. The correlation coefficient,  $N_{KT}$ , between CPTU pore pressure adjusted cone stress and vane shear stress is about 15.

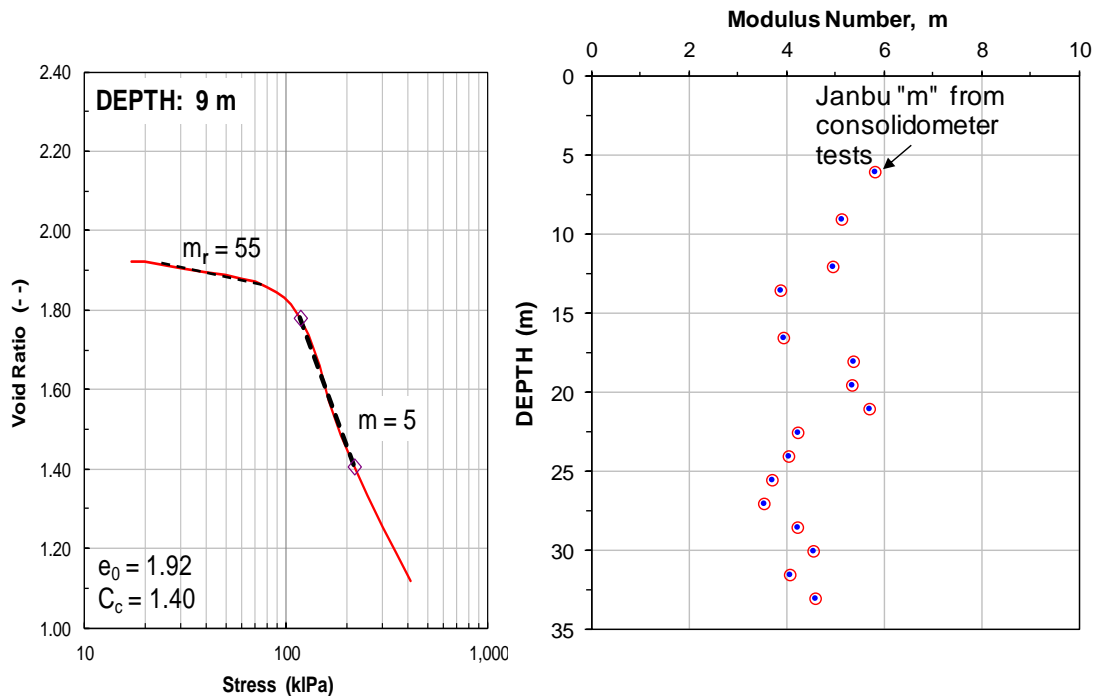
Fig. 3 Typical results of a consolidometer test and distribution of modulus number determined from consolidometer tests and from CPTU cone stress. The depth scale is from original ground surface; Elev. +3.5 m.

Oedometer tests show the soil to be very compressible with a Janbu modulus number ranging from about 4 through 6. The tests indicate that the preconsolidation margin is small; the clay is essentially normally consolidated. The reloading modulus number,  $m_r$ , is approximately ten times larger than the virgin number,  $m$ . Figure 3 shows a void ratio vs. stress diagram on a soil sample from a depth of 9.0 m at the site and the distribution of modulus number determined in consolidometer tests

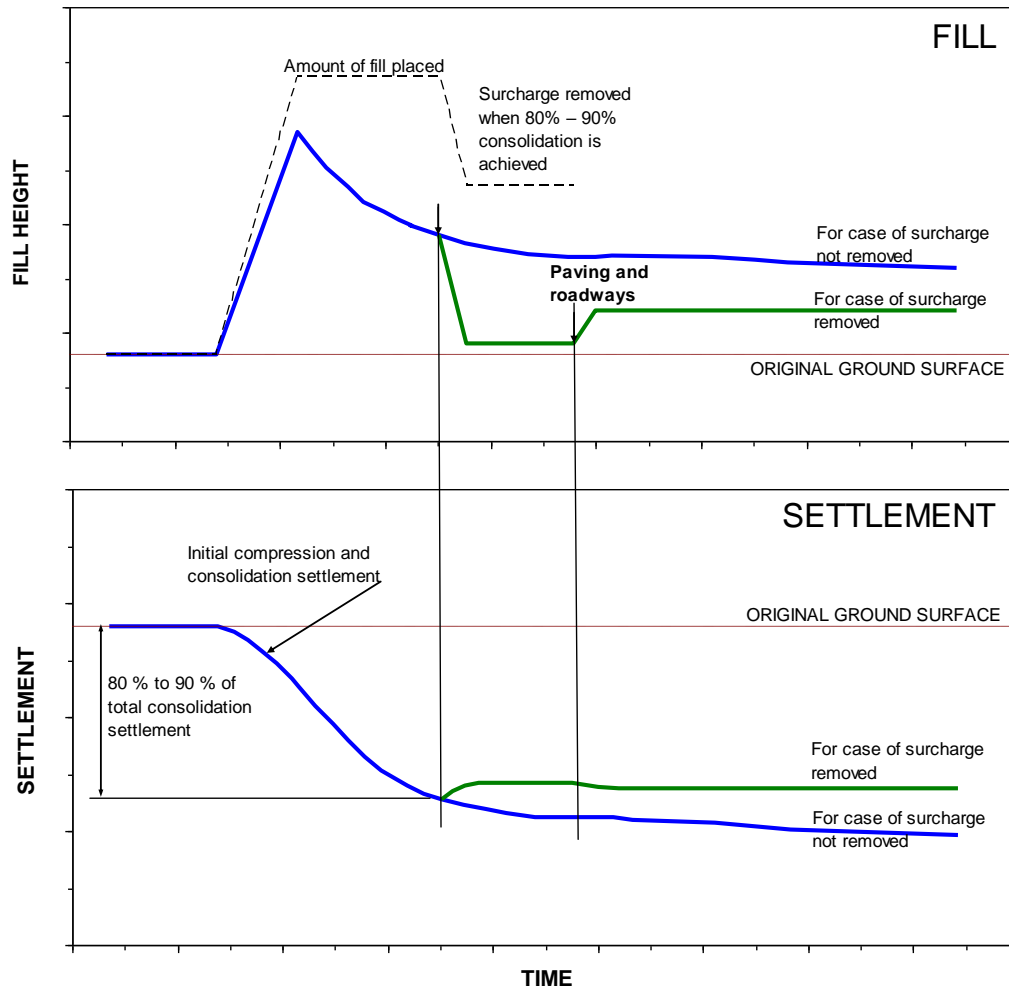
Fig. 4 Principles of wick drain and preloading site improvement work

The main approach to use of the wick drains and preloading site improvement work as applied to the project are illustrated in Figure 4, showing the development of immediate compression and consolidation settlement. The effect of secondary compression is not shown. The figure shows that the amount of fill actually placed will be larger than that indicated by the fill surface elevation, as some of the fill is placed in order to maintain the elevation, i.e., compensate for the settlements.

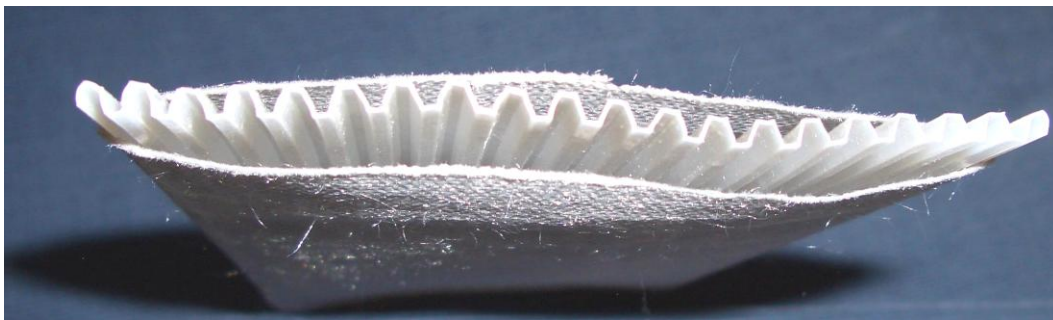
Fig. 5 Photo of the wick drain used for the project

The wick drain used for the project is a 100 mm wide and 3 mm thick and consists of a corrugated, 0.15 mm thick, plastic core wrapped with a synthetic filter. A photo of the wick drain is shown in Figure 5. The wick drain shown is not robust and could flatten and become squashed at large soil stress, which would impair the flow through the drain, which, in the extreme, could cause it to cease to function. In previous experience of the senior author with similarly designed types of drain, they were not recommended for use to depths larger than 10 m to 15 m including the fill height.

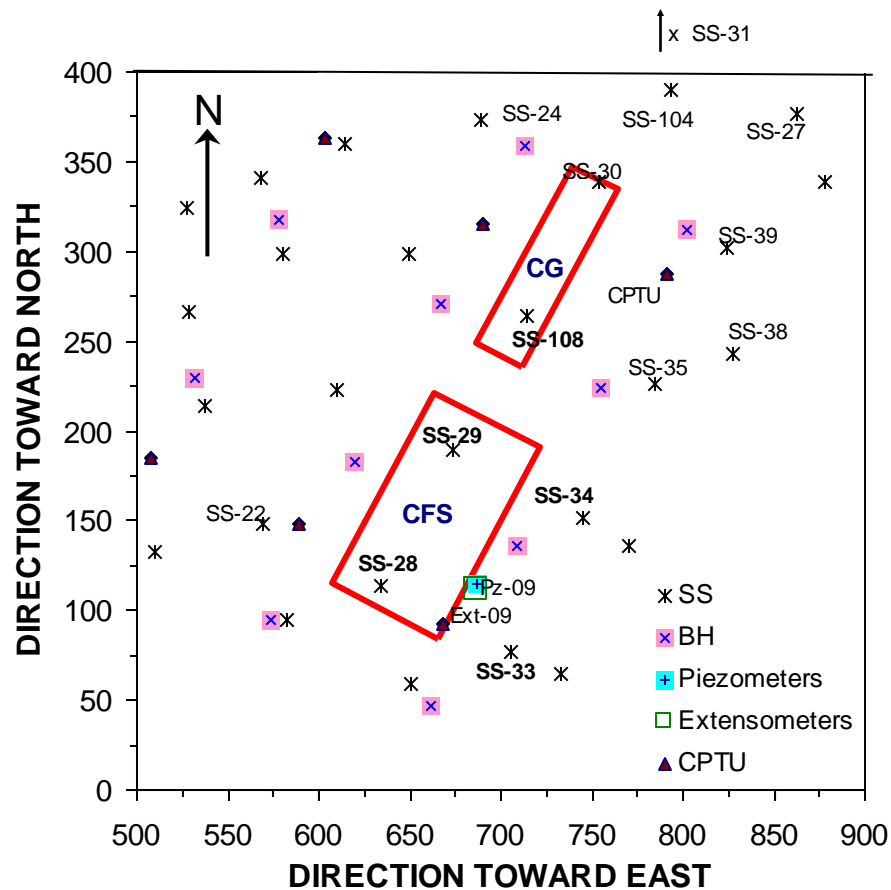
Fig. 6 Locations of CFS and CG buildings and layout of field instrumentation

To monitor the settlement, in February 2009, before the placing of the fill, a large number of settlement benchmarks (SS-plates) were installed on the original ground surface. Pore pressure was measured in three locations (Pz) near the buildings with piezometer tips installed at depths of 5 m, 15 m, and 25 m. Settlement distribution with depth was measured at the same three locations by means of extensometer gages (Ext) placed at 10 m, 20 m, 26 m, and 30 m depths in the clay (Ext-09). Figure 6 shows the layout of the two buildings included in this paper and the layout of the benchmarks etc. within and outside the building footprints.

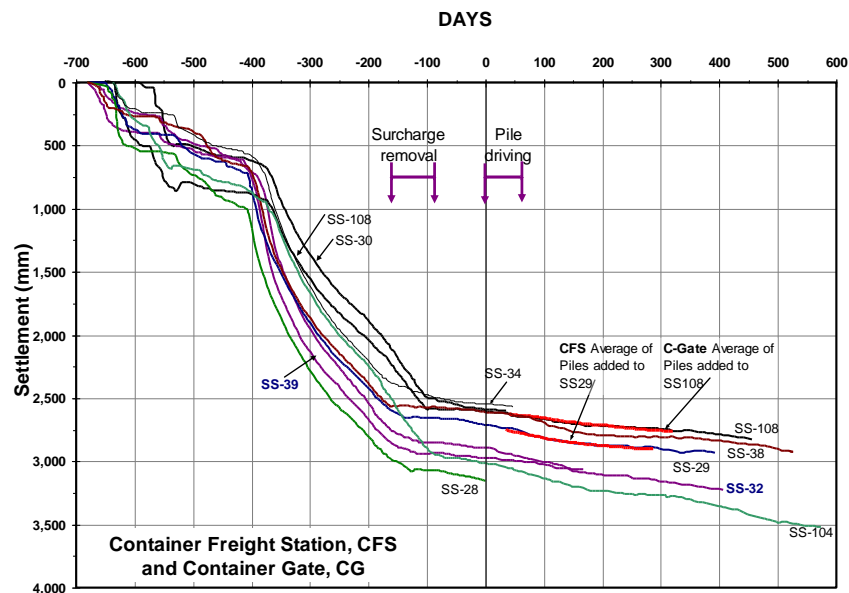
Fig. 7 Ground surface and pile settlements

Figure 7 shows the settlements measured by the SS-plates at or near the buildings. Day 0 is December 1, 2009, the day of the start of the pile driving for the two buildings, labeled CFS and CG. Several SS-plates were damaged or had to be removed during the construction. However, two SS-plates within each building footprint (SS-28 and SS-29, and SS-108 and SS-30) were functioning and several settlement plates outside and near the buildings were also available for continued monitoring. The records show that after removal of the surcharge, the settlement during the next 300 days amounted to about 250 mm, about four to five times more than anticipated. The average settlement at Day 0 (December 1, 2010) was 2.90 m. The total settlement during the consolidation period differs by about 1.0 m between the various SS-plates. The difference is mostly due to the fact that the monitoring started at different times after the fill had been placed near the plate. The trends immediately before and after the pile driving are quite similar. Figure 7 also shows the average settlement of the pile heads in the two buildings superimposed on the settlements measured for SS-28 and SS-108 (discussed in regard to Figure 12).

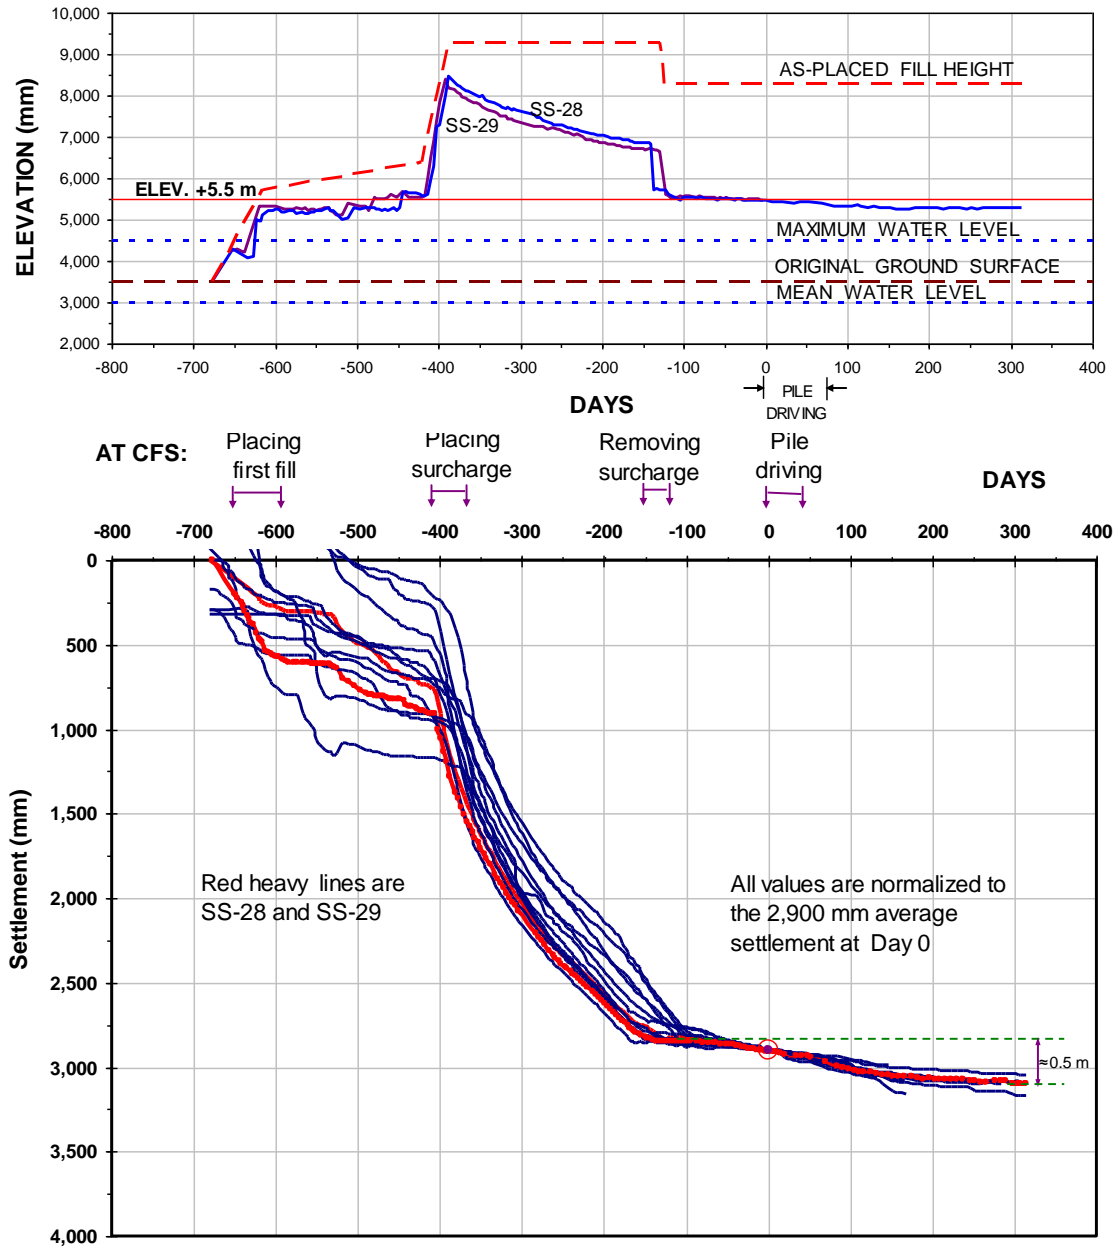
Fig. 8 Fill and surcharge elevation and ground surface settlement

Figure 8 shows the settlements measured at the plates when normalized to the average settlement of 2,900 mm at Day 0 in order to illustrate the settlement development after the removal of the surcharge. The figure also shows the fill height measured at the two buildings (at SS-28 and SS-29). The dashed line indicated as "as-placed fill height" is the measured fill elevation plus the measured settlement. The volume of soil and fill settling below the water table causes a reduction of the imposed stress, which has to be and has been considered in the settlement analysis.

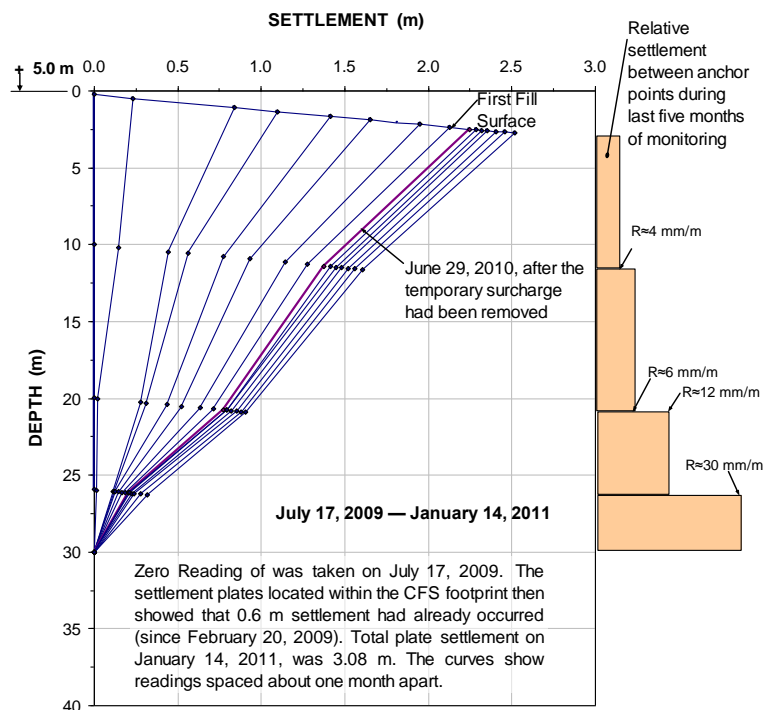
Fig. 9 Distribution of settlement with depth

Figure 9 shows the settlement distribution with depth as measured at extensometer station, EXT-09 next to the CFS building at 10, 20, 26, and 30 m depths (original depths) from July 17 through January 14, 2011, i.e., Days -504 through 42, when the Ext-station had to be removed as it was in the way of the pile driving. The four settlements anchors were referenced to the presumed zero for the fifth anchor point placed at 30 m depth. The ground surface settlement (uppermost anchor) was found to agree approximately to the average of SS-28, SS-29, SS-33, and SS-34 for the same time period. At the installation of EXT-09, a ground surface settlement of 0.6 m had already developed. The settlement distribution is almost linear from the fill surface to zero at 30 m depth. The sketch to the right in Figure 9 shows the relative settlement within the anchor points as measured during the last five months, i.e., after the removal of the surcharge. The sketch shows that below about 20 m depth, the ongoing relative settlement is twice to several times larger than above that depth. Evidently, consolidation continued below about 20 m depth after the removal of the surcharge.

the piles settled and settled at the same rate of settlement as that of the ground surface. This indicates that the settlement occurred in the deep soil layer below the pile neutral plane, which can be estimated to be at somewhere between the depths of 13 m and 20 m for the two pile lengths. The definite conclusion from this indication is that the consolidation was not completed in the lower portion of the profile, as also indicated by the observation about the ongoing consolidation below about 20 m depth (Figure 9). It would seem that the wick drain used was not suitable for the deep installation.

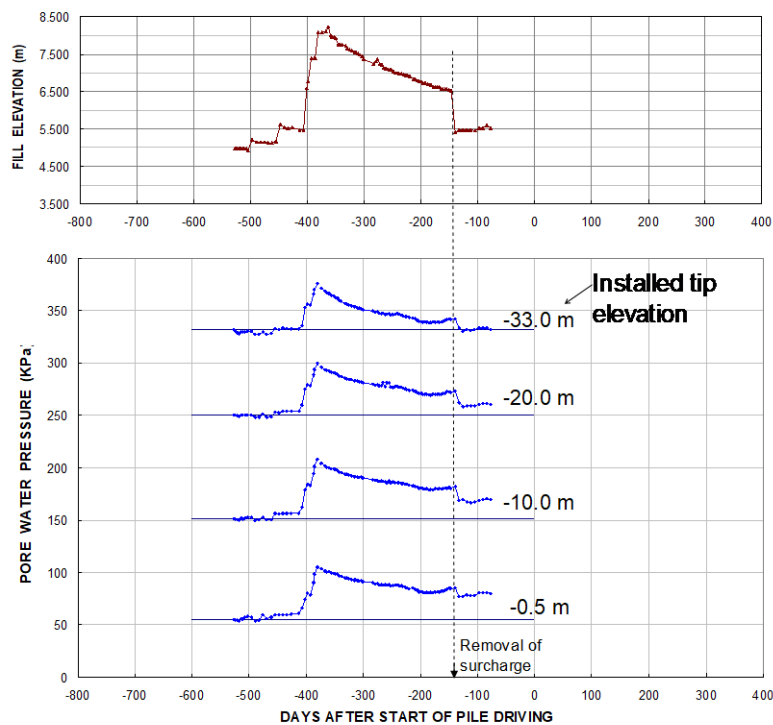
Fig. 10 Fill height and pore pressures measured between Days -527 and -77 at the CFS building

Figure 10 shows the pore pressures measured at the CFS building at Elev. -0.5 m, -10.0 m, -20.0 m, and -33.0 m from June 24, 2009, through September 17, 2010; Day -527 through Day -77 (until about three months after removing the surcharge). The figure also includes the fill height measured next to the piezometer station. The figure shows that the first fill placement across the site (to Elev. +5.5) only resulted in a modest increase of pore pressure, whereas the subsequent placement of fill to full height gave a distinct pore pressure response. The modest initial response could be interpreted as an effect of a small preconsolidation margin.

The 5.8 m as-placed fill, which imposed a maximum stress of 100 KPa, resulted in a maximum pore pressure increase of 47 KPa, 50 KPa, 43 KPa, and 37 KPa measured at the four piezometers, respectively. The pore pressures appeared to have stabilized at about Day -200. When the surcharge was removed (about Day -150), the pore pressures reduced somewhat, and after removing the surcharge, the values of remaining pore pressure were 25 KPa, 20 KPa, 10 KPa, and 0 KPa, respectively, corresponding to about 50 %, 40 %, 20 %, and 0 % of the maximum values. The appearance of pore pressures remaining after the removal of the surcharge is due to that the measured pore pressures are referenced to the original piezometer depths. The pore pressures values from 33 m depth were probably affected by the proximity of the sand layer 2 m below and, also, by that the settlement at that depth must have been small. Figure 11 shows the pore pressure distribution versus depth. As seen, when the measured pore pressures are adjusted to the settlement of the piezometer, the measurements indicate that the pore pressures had returned to the original level.

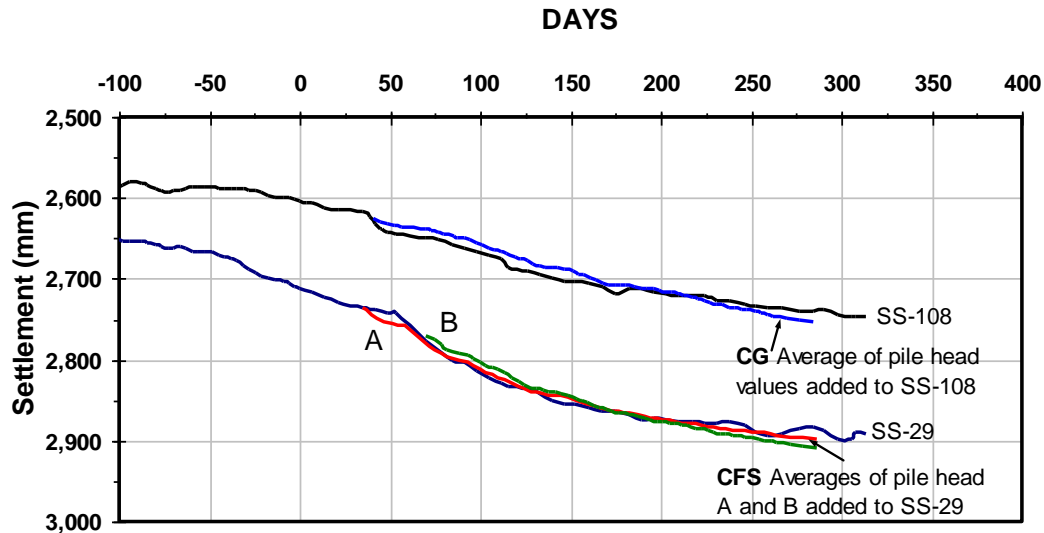
Fig. 12 Settlements of SS-29 and SS-108 located within the footprint of the buildings and the average settlement of the pile heads from end of driving.

Starting at Day 0, piles were driven to predetermined depths for the buildings. The pile embedment length for the CFS and CG building were 18 m and 28 m, respectively. When all piles had been driven, the elevations of the pile heads were from then onward intermittently monitored. Figure 12 combines the settlement measured by SS-29 and SS-108 located within the footprint of the CFS and CG buildings and the pile head settlement values. First to take note of is that the area continued to settle at a rate much larger than anticipated in the design; second, also

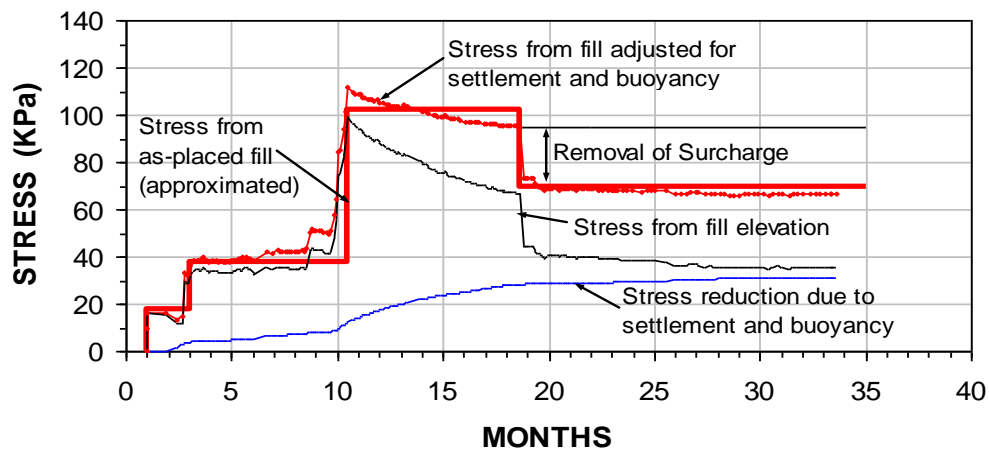
Fig. 13 Actual loading and unloading stresses

The loading input is illustrated in Figure 13, which shows the stress from the measured height of fill (SS-29) and the reduction of the fill height due to the soil and fill settling below the water table vs. months from the project start. The figure shows the correction of imposed stress for the loss of applied stress due to buoyancy. The stress adjusted for this effect is indicated in the figure and approximated to three loading and one unloading occasions.

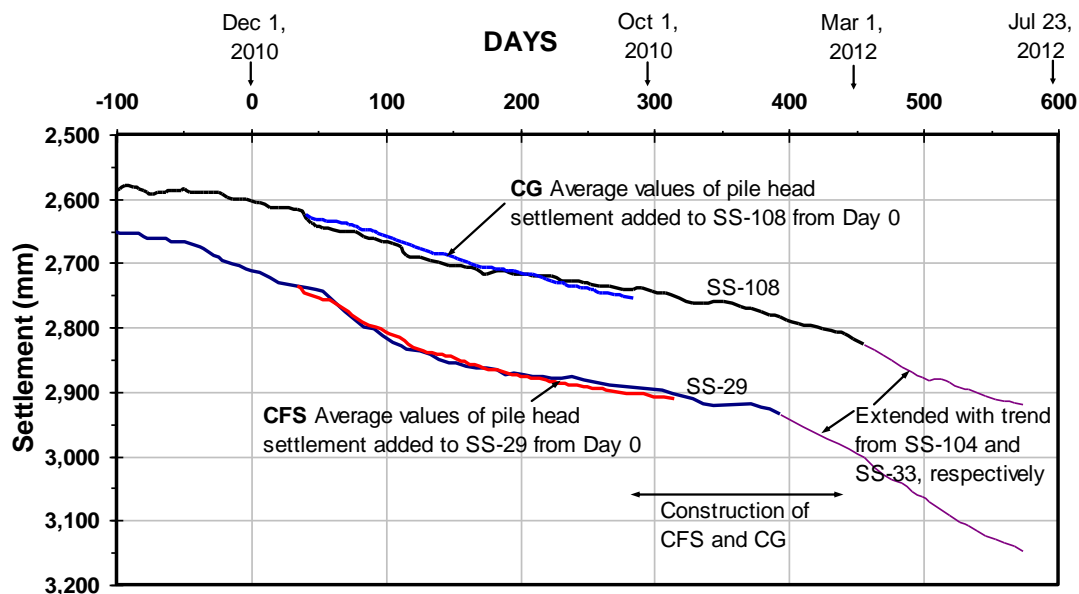
Fig. 16. Settlements measured at the SS-plates near the respective building and settlement of the piles before lengthening

The pile head elevations were monitored until the pile were to be lengthened and the measurements showed the piles to settle at the same rate as the settlement plates, as indicated in Figure 16. The piles will be subjected to drag loads that are larger than the working loads placed on the piles. However, this is of no concern as the pile is structurally able to resist the resulting axial loads—the dead load from the building plus drag load.
